Adams Avenue/49th Street/ Lorraine Drive

Pedestrian Safety Study

Prepared for:
City of San Diego

May 2021

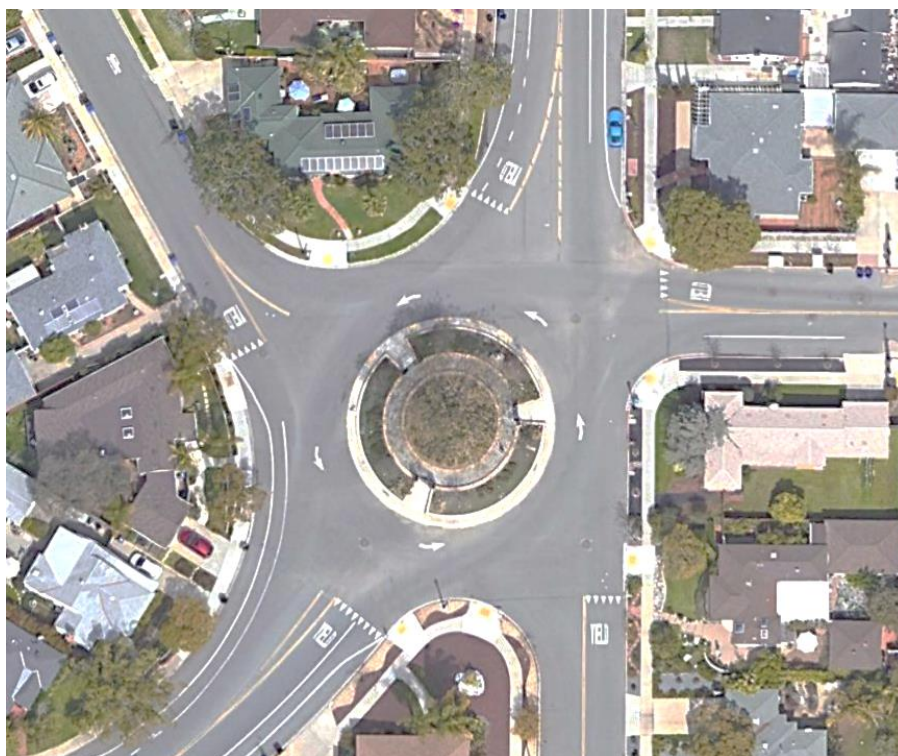
Figure 1-1: Existing Condition (Before Splitter Islands)

The roundabout configuration is unique and consists of five-legs with a single circulating lane and minipark located at the center. The entry and exit lanes are separated by channelized yellow striping. The existing condition before improvements were made is shown in **Figure 1-1**.

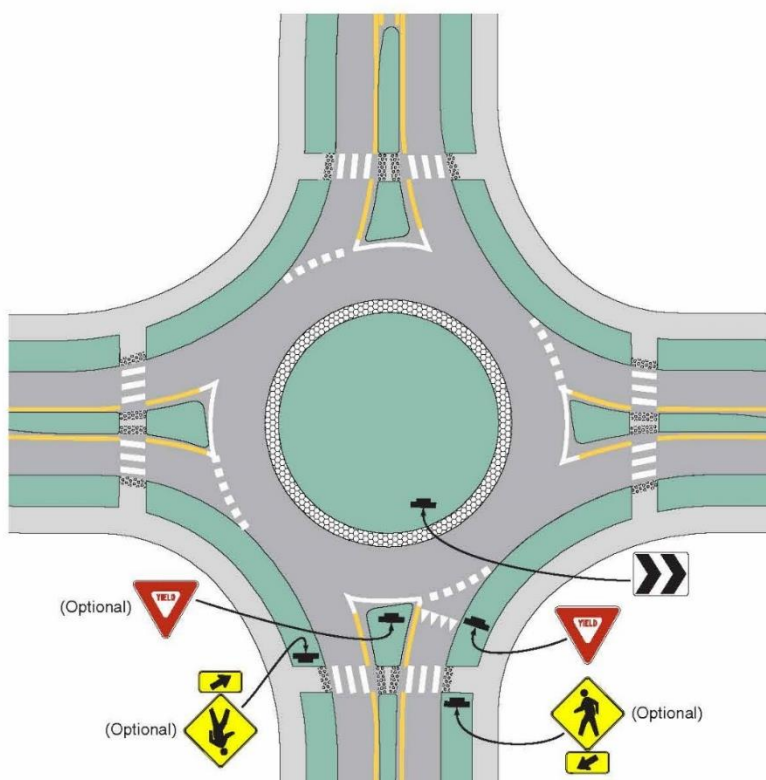
Figure 2-1: California MUTCD Example

According to the California MUTCD Figure 2B-21 through Figure 2B-23 examples of regulatory and warning signs for a mini, one-lane, and two-lane roundabouts, use of the warning sign W11-2 and the diagonal downward pointing arrow plaque W16-7P are optional. Figure 2B-22 of the California MUTCD for a one-lane roundabout is shown in **Figure 2-1** below:

Figure 2B-22. Example of Regulatory and Warning Signs for a One-Lane Roundabout

Based on the California MUTCD, the use of the warning sign W11-2 and the diagonal downward pointing arrow plaque W16-7P are optional. The CA MUTCD further states that the use of warning signs shall be based on an engineering study or engineering judgement.

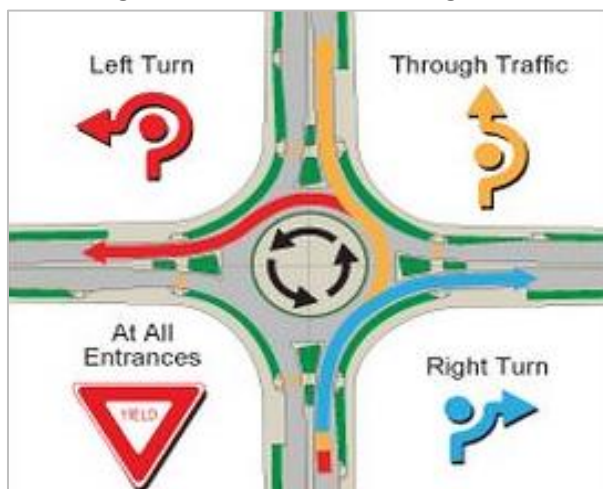
Figure 3-1: Roundabout Navigation

A roundabout is a form of intersection control that requires vehicles to travel in a counterclockwise direction around a central island. Vehicles entering or exiting the roundabout must yield to other vehicles, bicyclists, and pedestrians.

- Slow down on the intersection approach and navigate the roundabout with caution.
- Yield to pedestrians and bicyclists crossing the roadway.
- Watch for signs and pavement markings that guide or prohibit certain movements.
- Enter the roundabout when there is a big enough gap in traffic and is safe to do so.
- Drive in a counterclockwise direction and do not stop or pass other vehicles.
- Use turn signals when changing lanes or exiting the roundabout.
- Continue around again if the exit is missed until return to the exit.

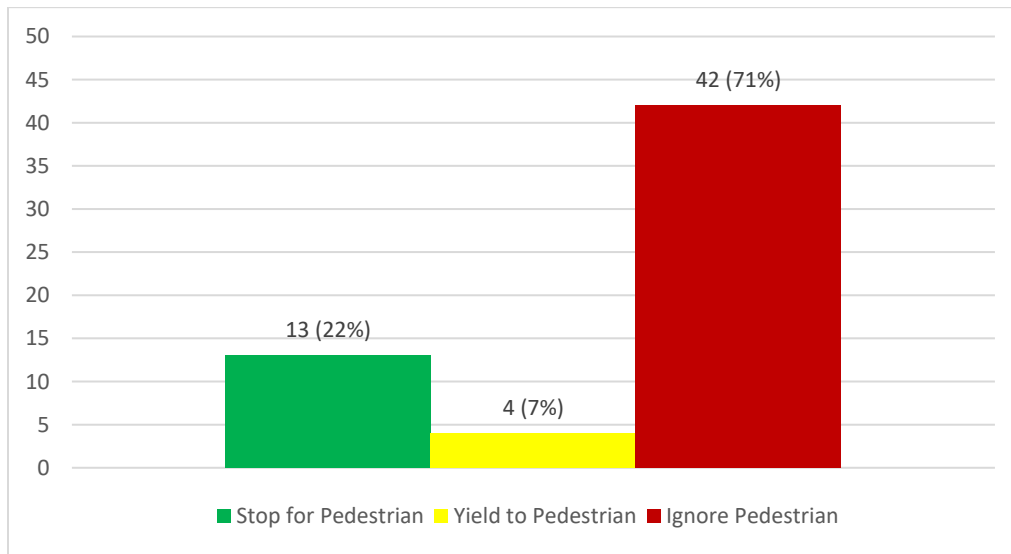
Figure 6-3: Driver Behavior with Pedestrian at Crossing Ramp

The weekday period vehicle and pedestrian volumes and interactions are higher than weekend conditions. The Friday, November 20, 2020 video data was further reviewed to evaluate driver and pedestrian behavior and the following tables and graphs present the results.

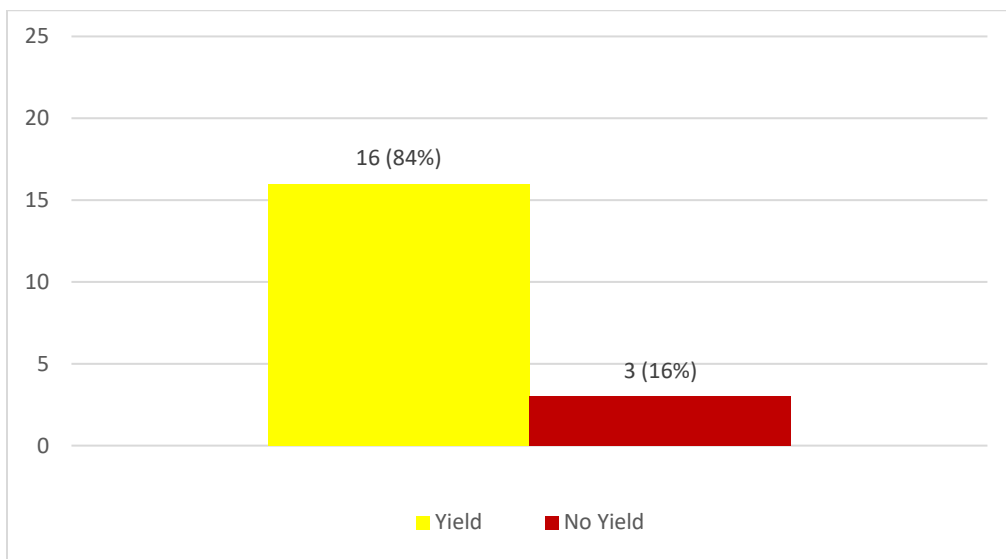
Figure 6-4: Driver Behavior without Pedestrian at Crossing Ramp

Note: This interaction occurs when a pedestrian is walking nearby the ramp but is not crossing at the ramp.

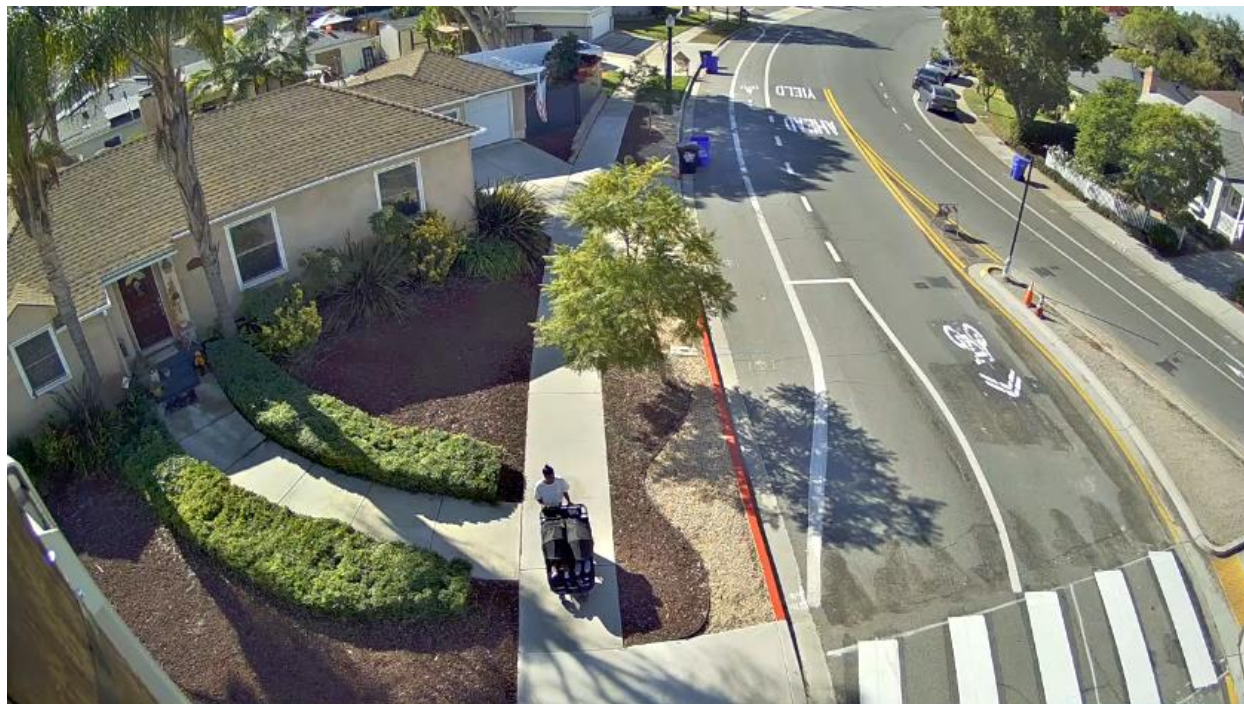
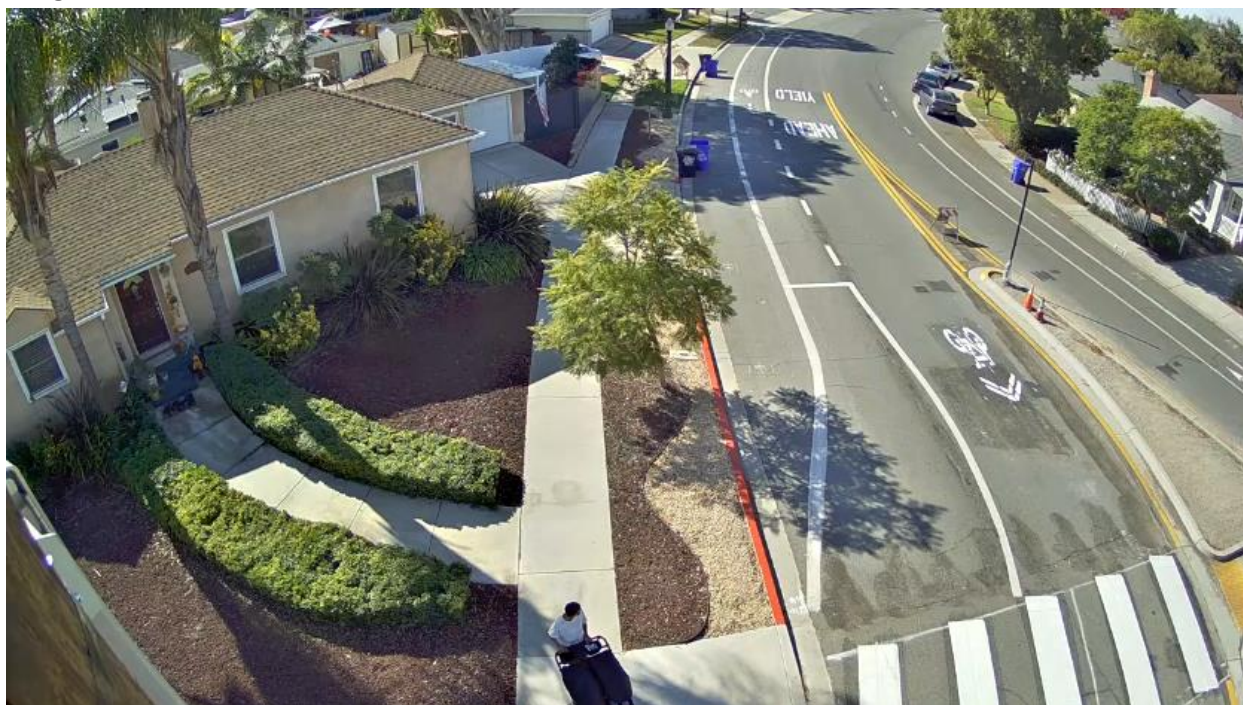
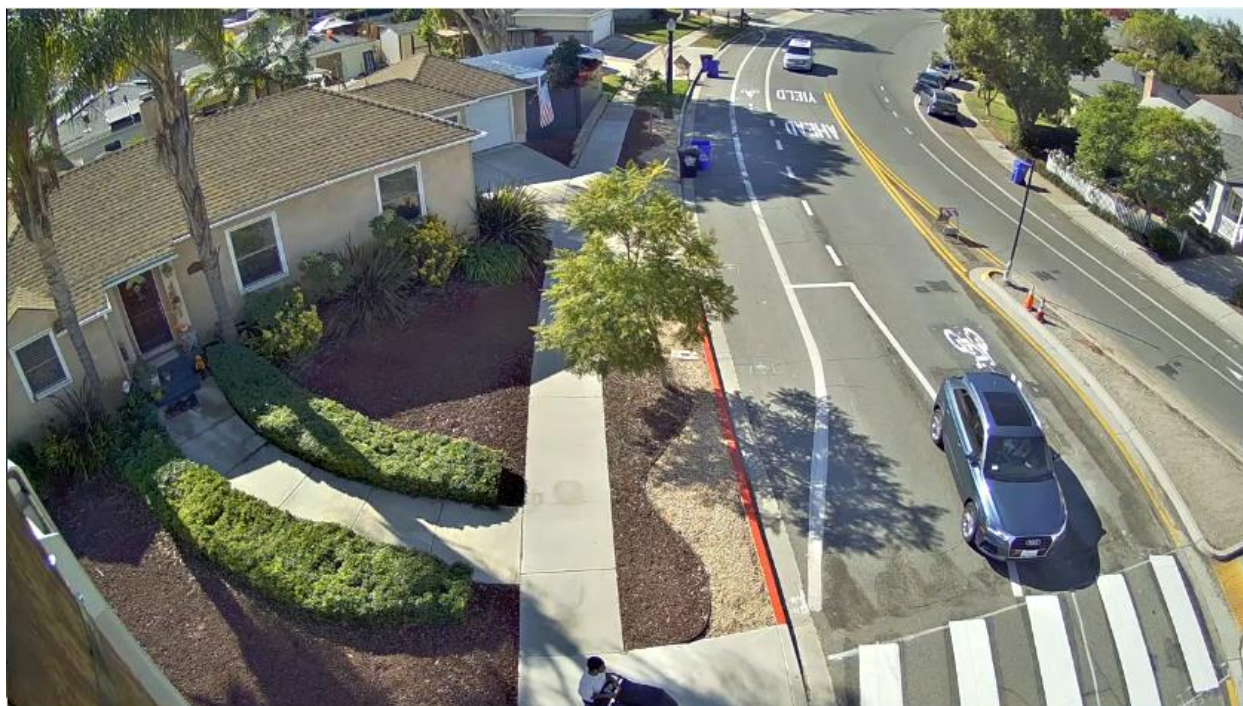
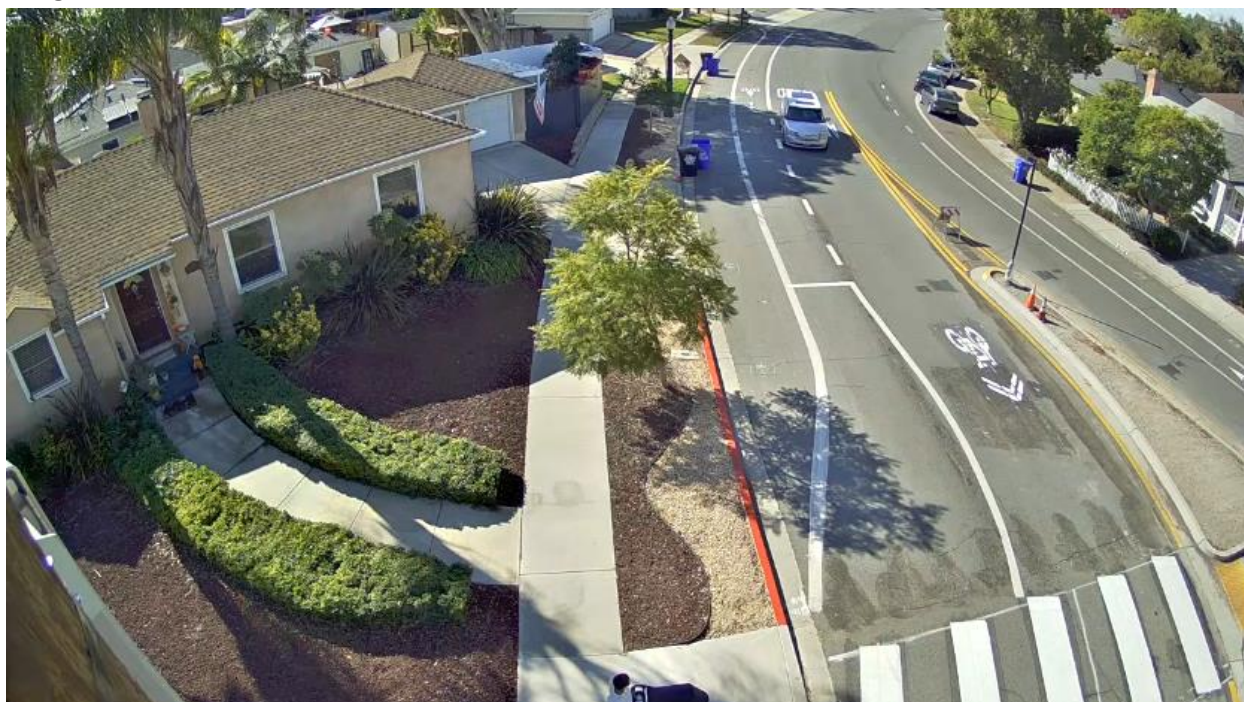
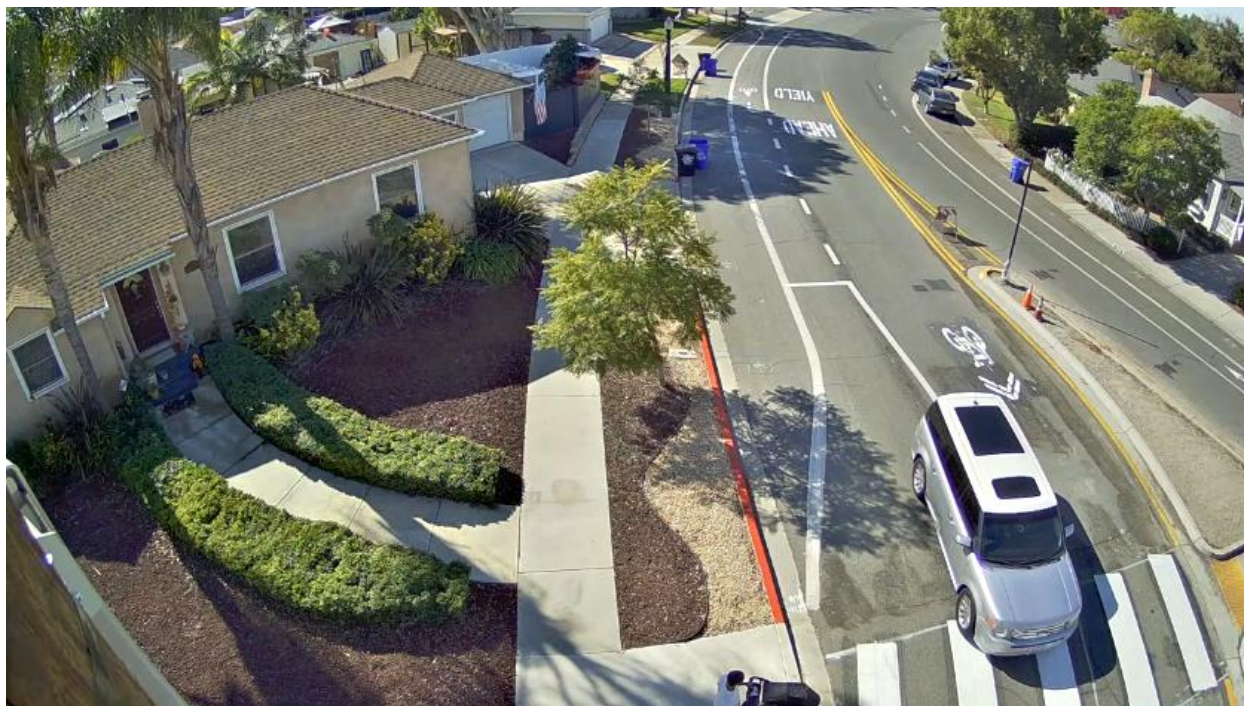
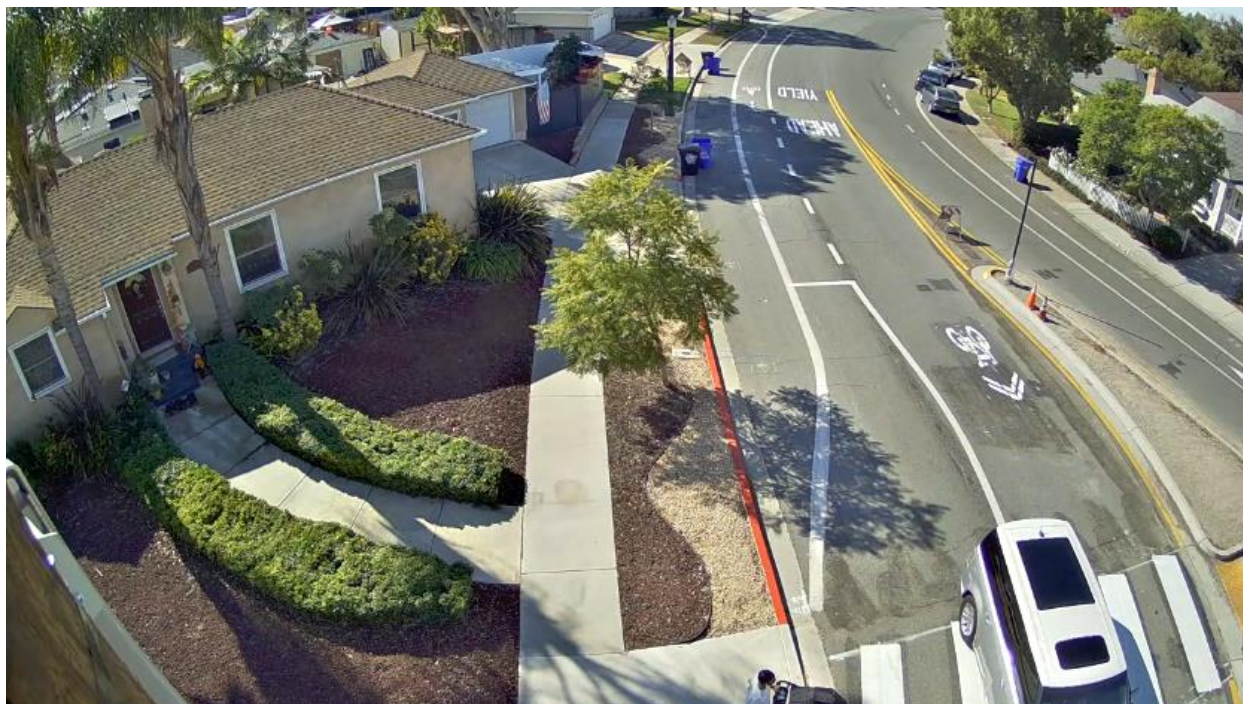
(Image 1-1) Pedestrian, with children in stroller, walks towards ramp. (Image 1-2) Pedestrian notices vehicle heading towards roundabout. (Image1-3) Pedestrian waits at ramp as vehicle ignores pedestrian, and is followed by another vehicle after a short gap. (Image 1-4) Pedestrian inches forward. (Image1-5) Pedestrian at edge of ramp and second vehicle also fails to yield. (Image1-6) Pedestrian crosses.

Installation of the warning sign W11-2 and diagonal downward pointing arrow plaque W16-7P at the pedestrian crossings is recommended to encourage driver awareness and increase safety.

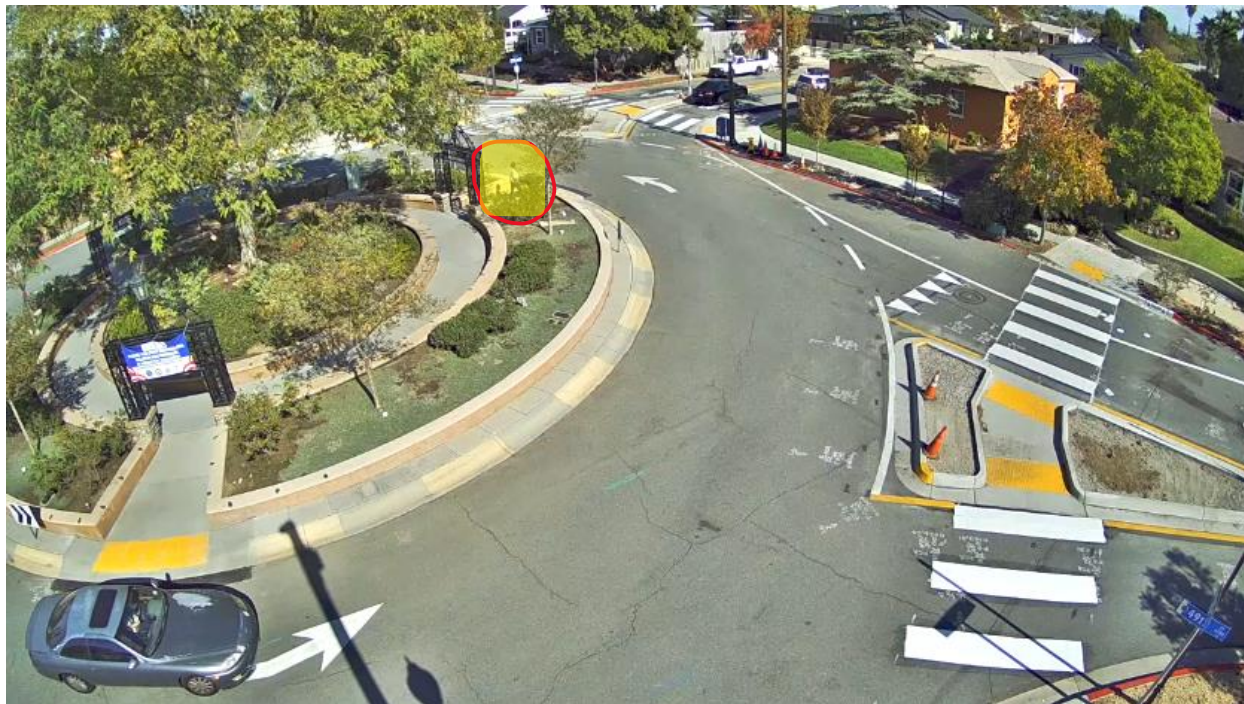
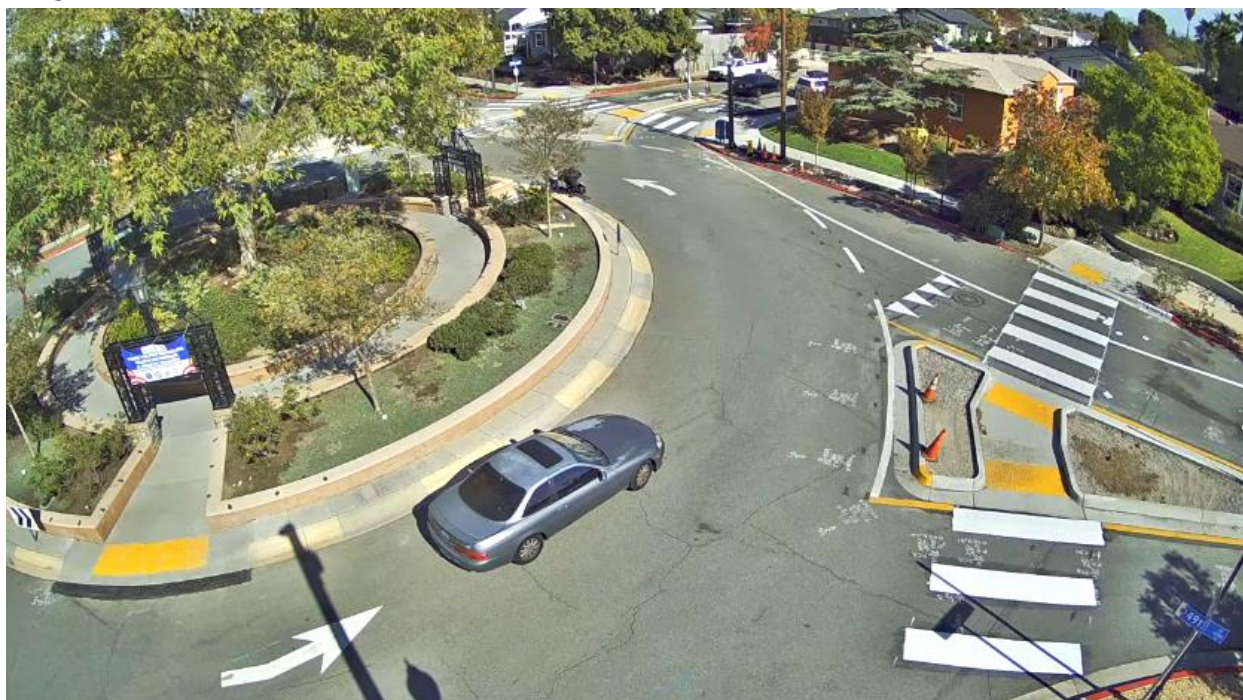
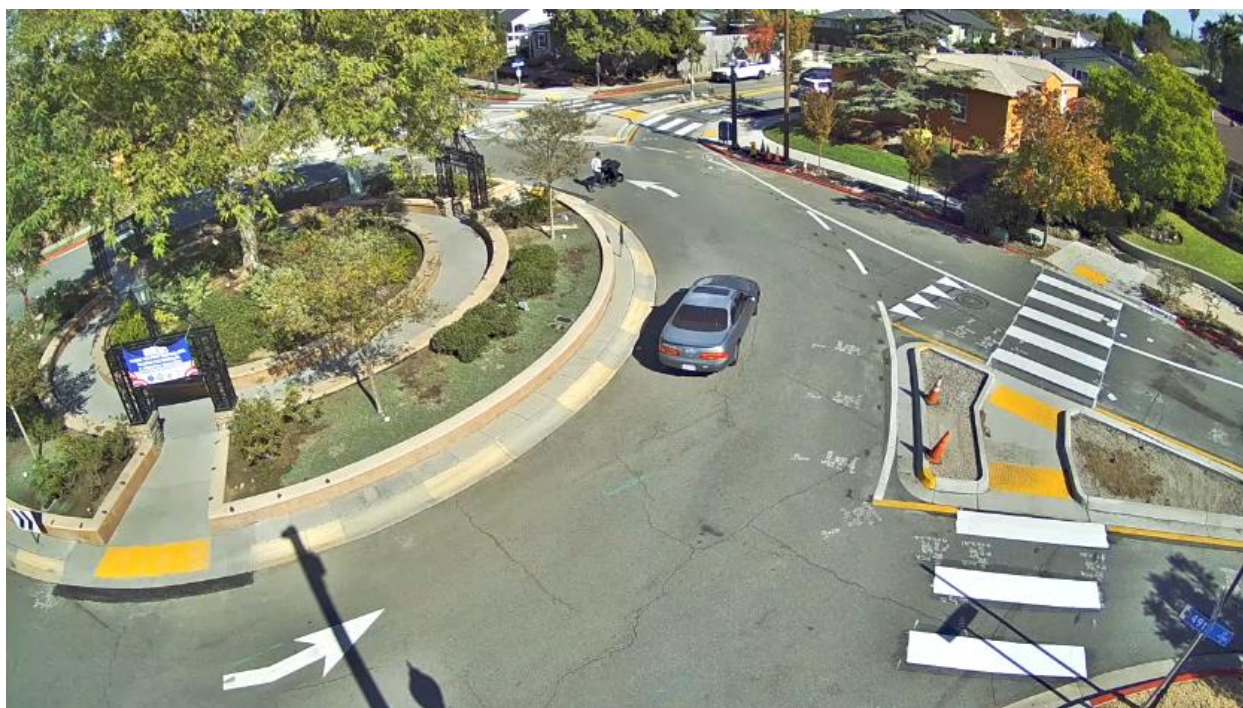
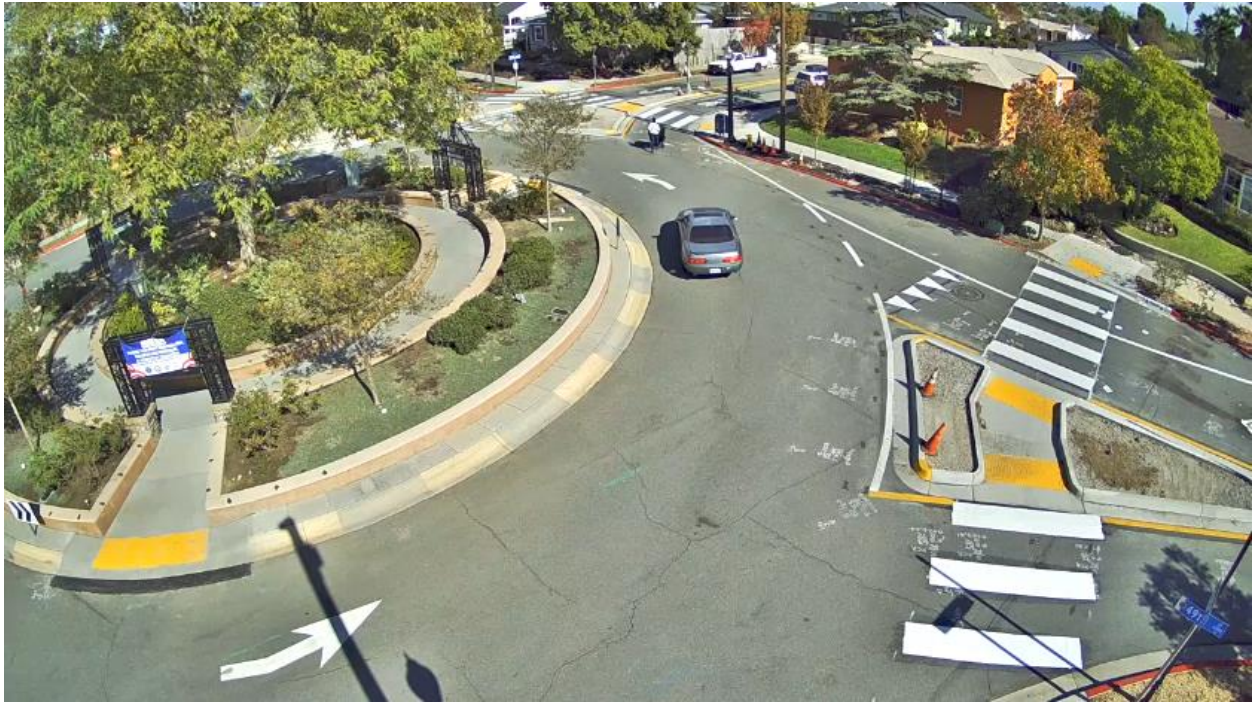
Interaction 2:

(Image 2-1) Pedestrian with stroller begins crossing from park in center of roundabout as car is moving on roundabout. (Image2-2) Driver sees pedestrian and begins to slow to give pedestrian more time to cross. (Image2-3) Pedestrian continues crossing and driver inches behind them. (Image 2-4) Pedestrian nearly finishes crossing and driver continues movement.

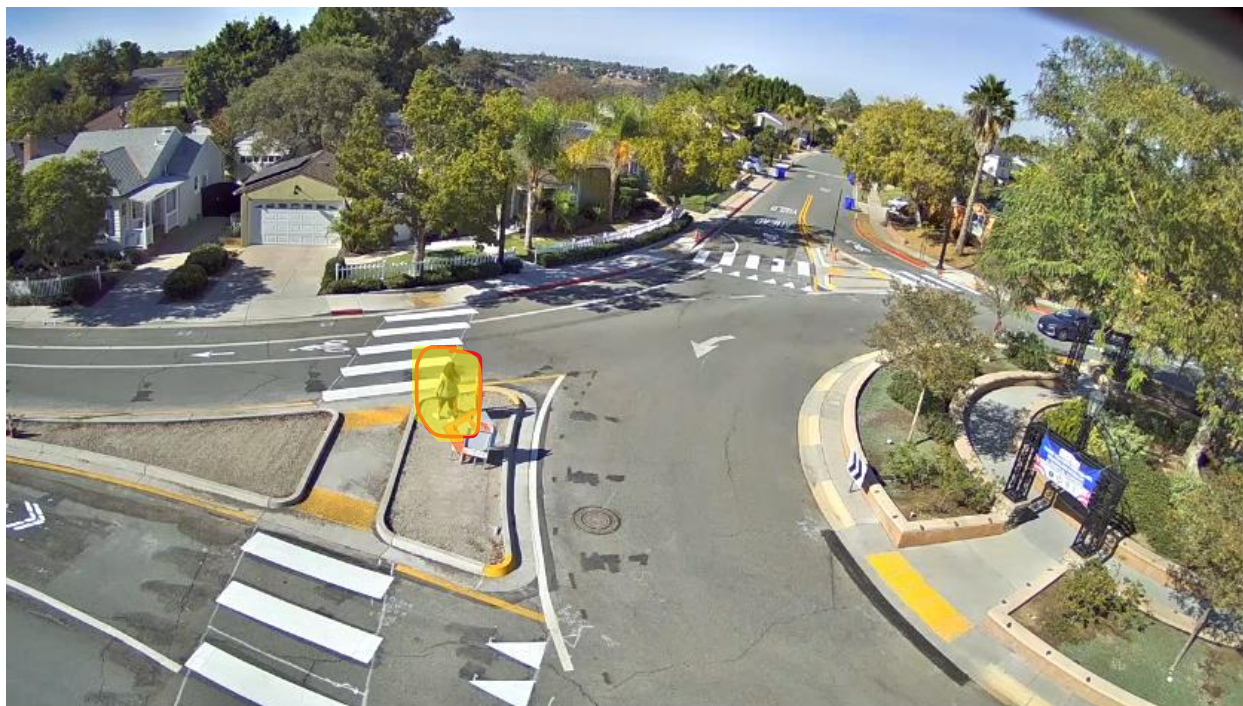
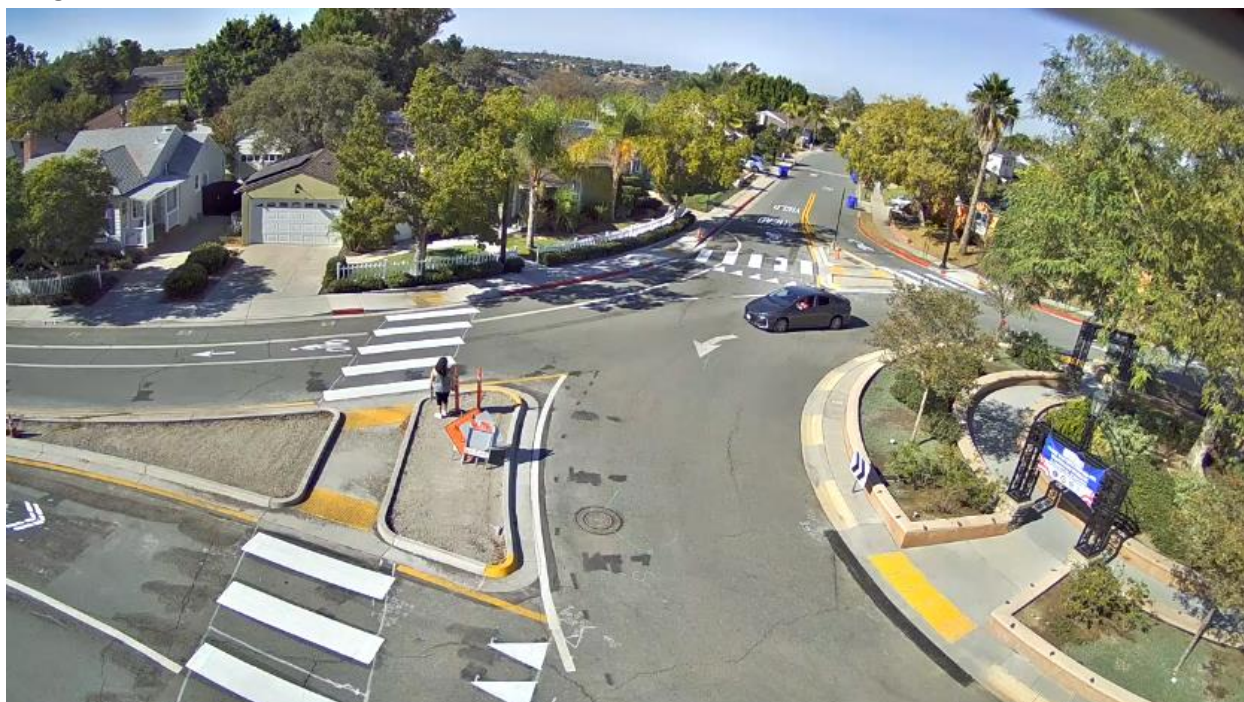
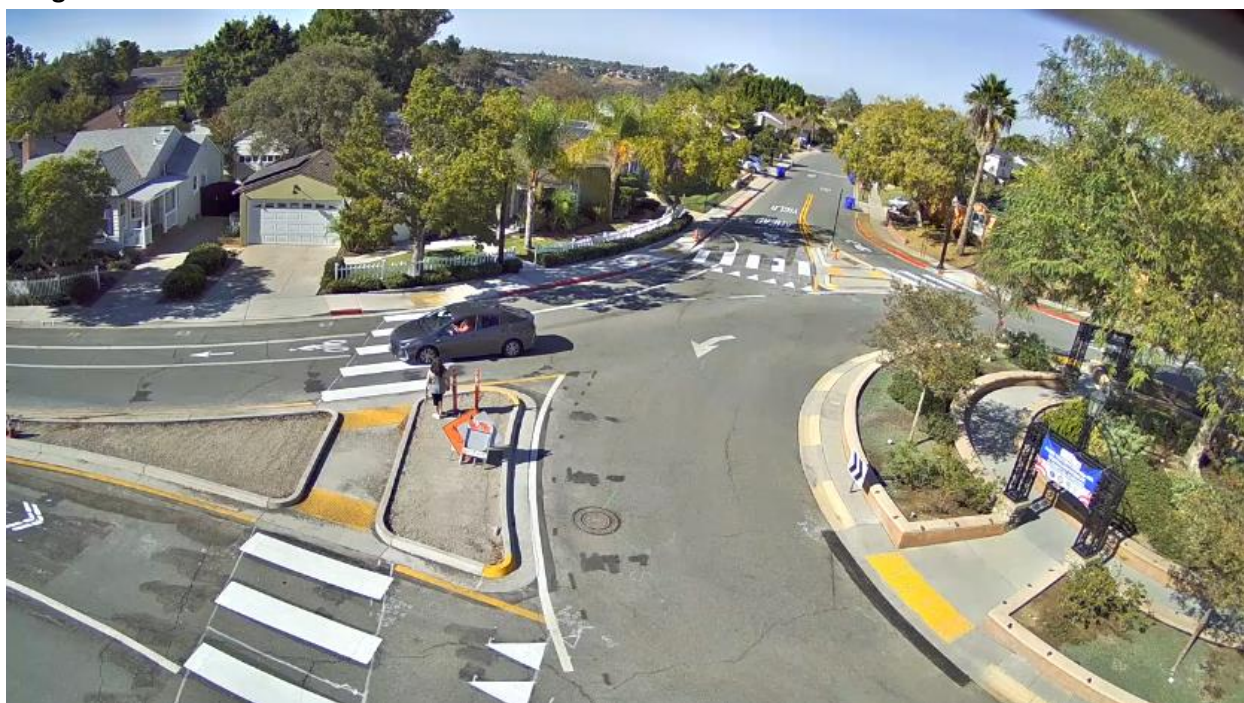
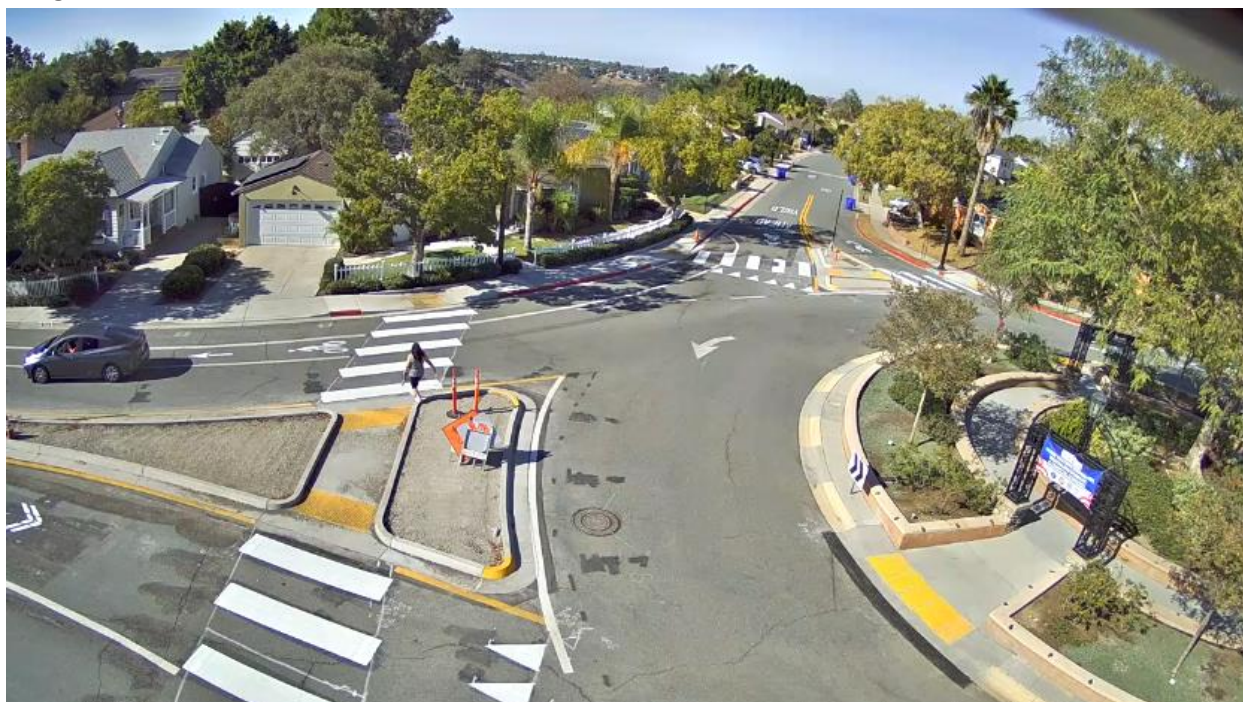
Interaction 3:

(Image 3-1) Pedestrian at island's ramp sees vehicle approaching and waits. (Image 3-2) Driver gets closer to crosswalk and pedestrian waits as vehicle is not slowing. (Image 3-3) Vehicle goes through crosswalk and pedestrian begins to cross afterwards. (Image 3-4) Pedestrian continues through crosswalk after being ignored by driver.

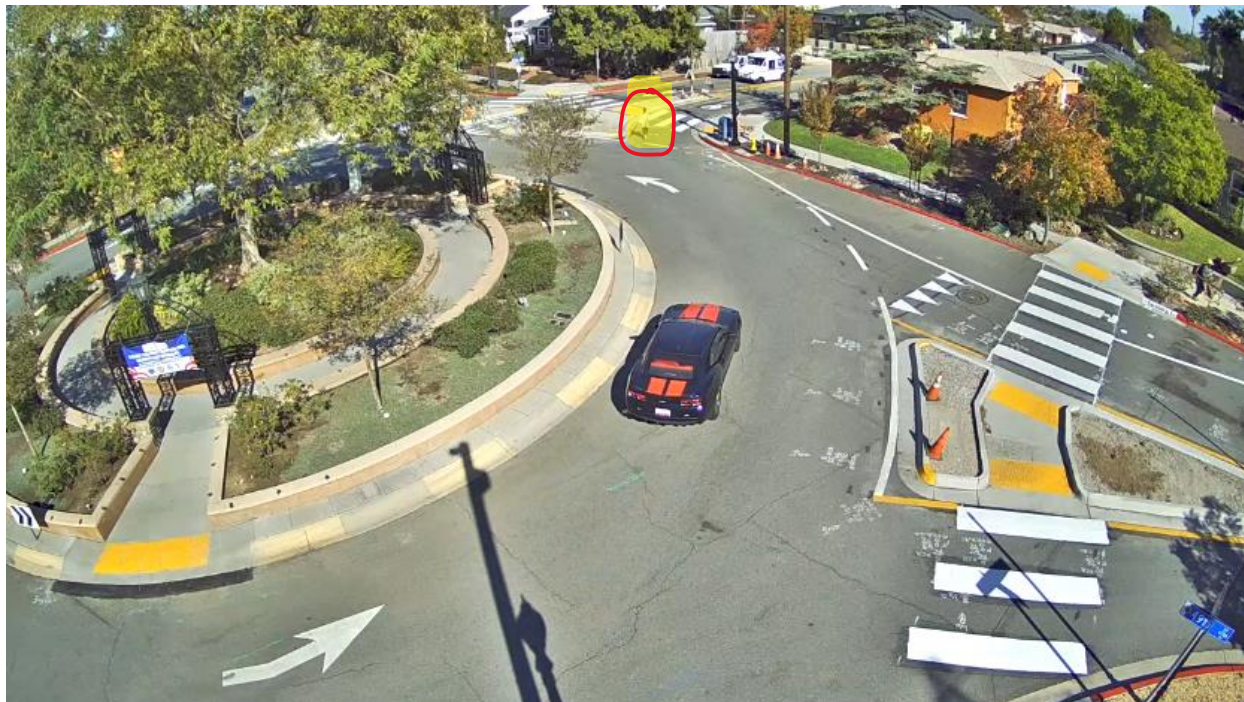
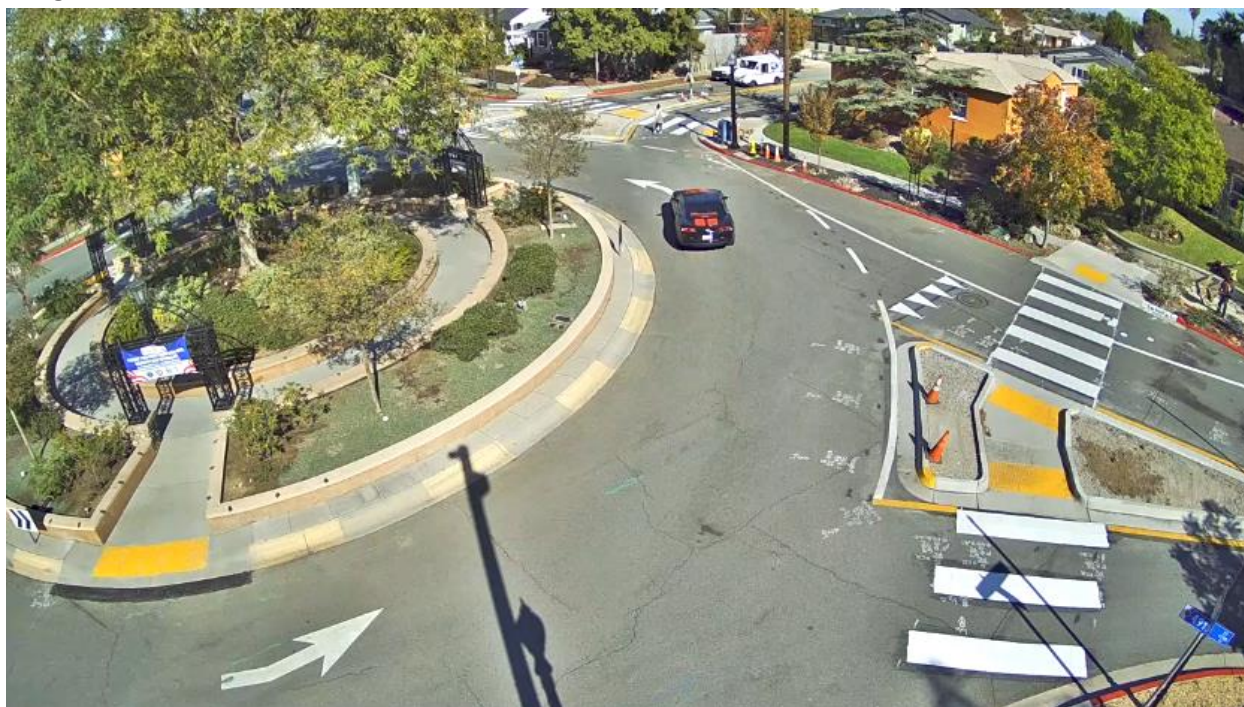
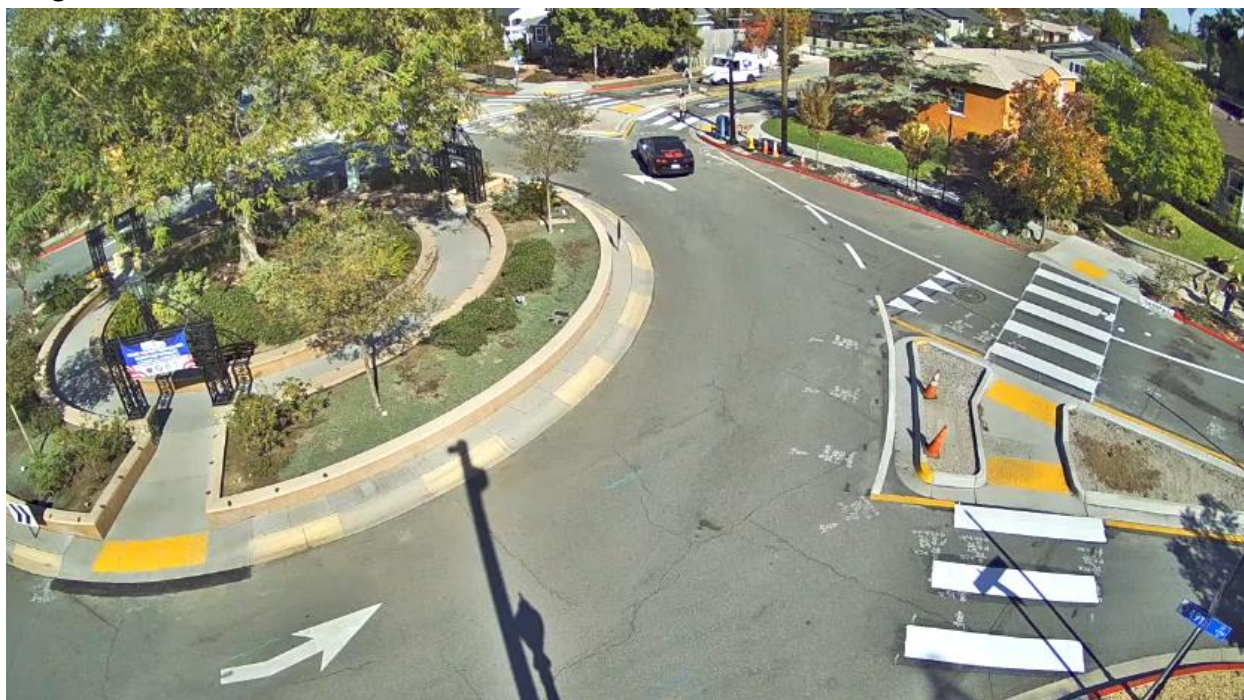
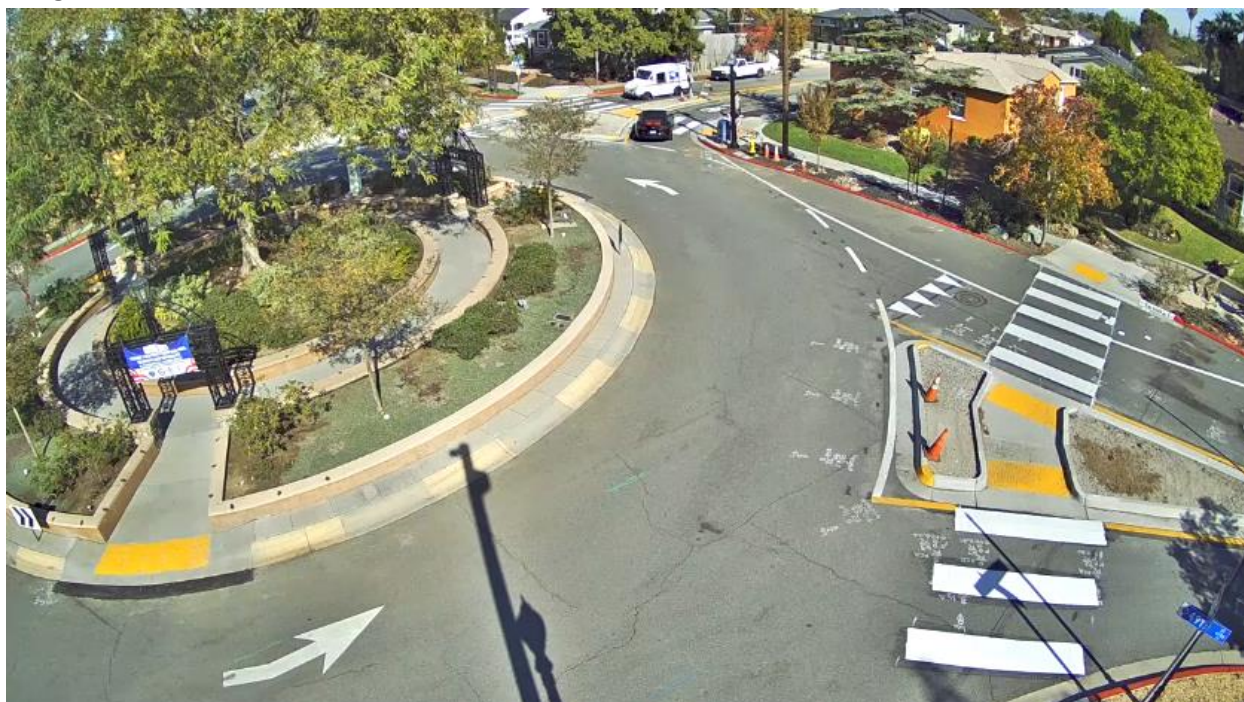
Interaction 4:

(Image 4-1) Pedestrian walking towards Adams East as driver is moving around roundabout. (Image 4-2) Vehicle is seen heading in the direction of pedestrian while pedestrian is still crossing. (Image 4-3) Driver inches forward pressuring pedestrian, almost pushing them onto the sidewalk. (Image 4-4) Driver passing through crosswalk as pedestrian takes first step onto sidewalk.
