Adams Avenue/49th Street/ Lorraine Drive

Pedestrian Safety Study

Prepared for:
City of San Diego

May 2021

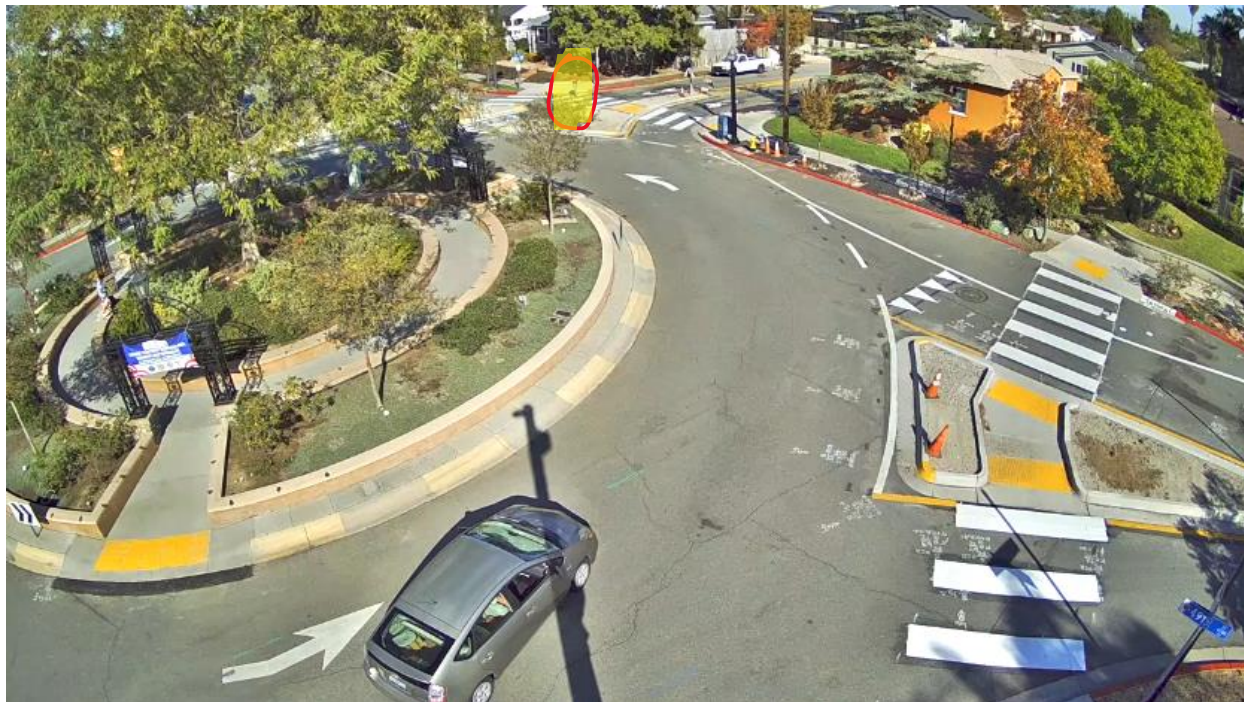
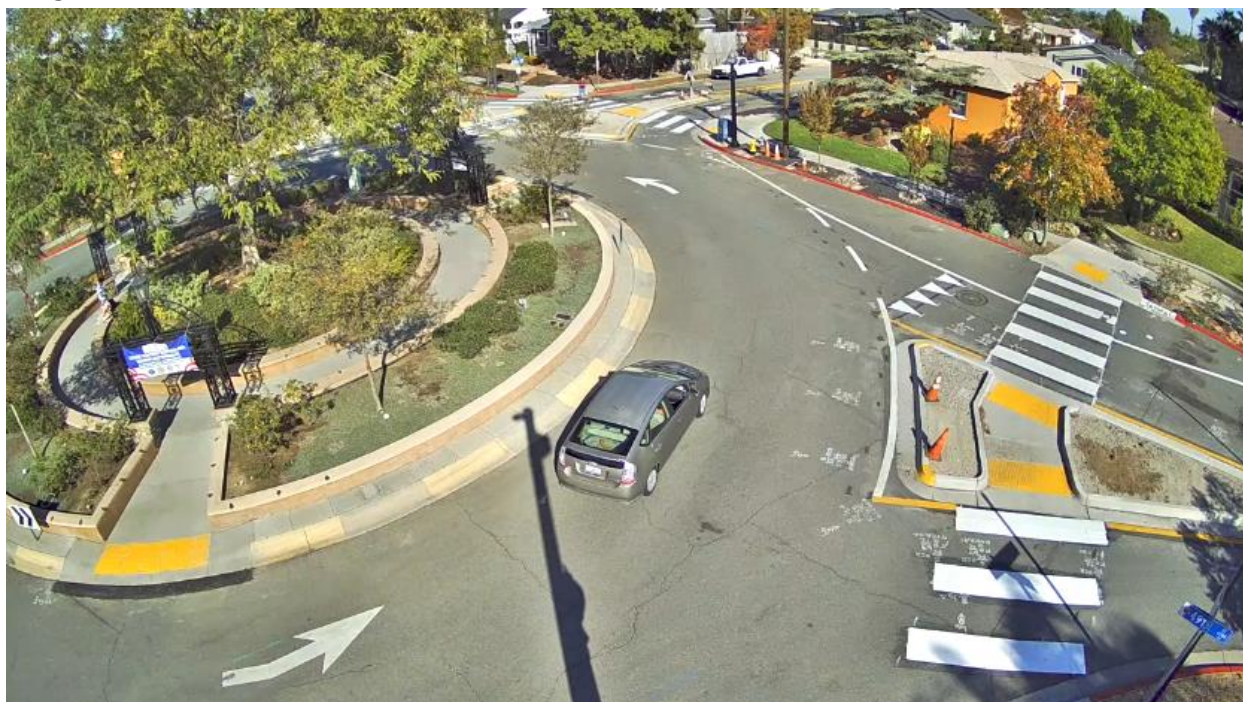
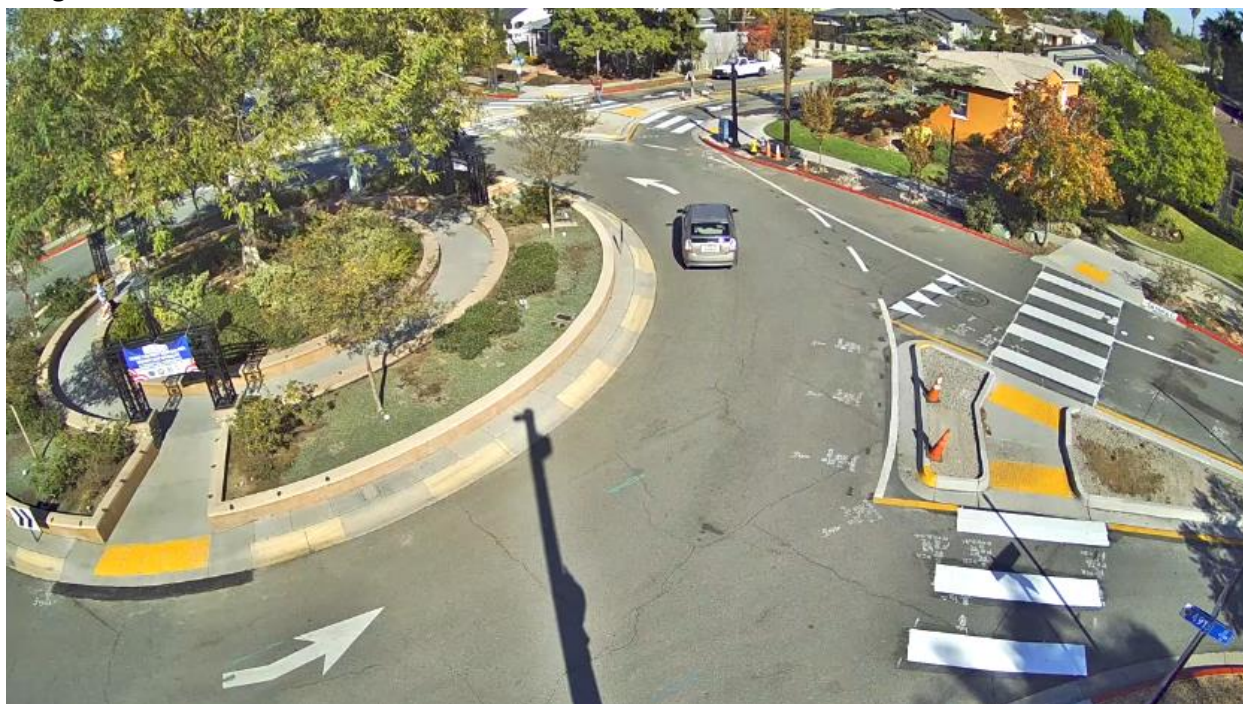
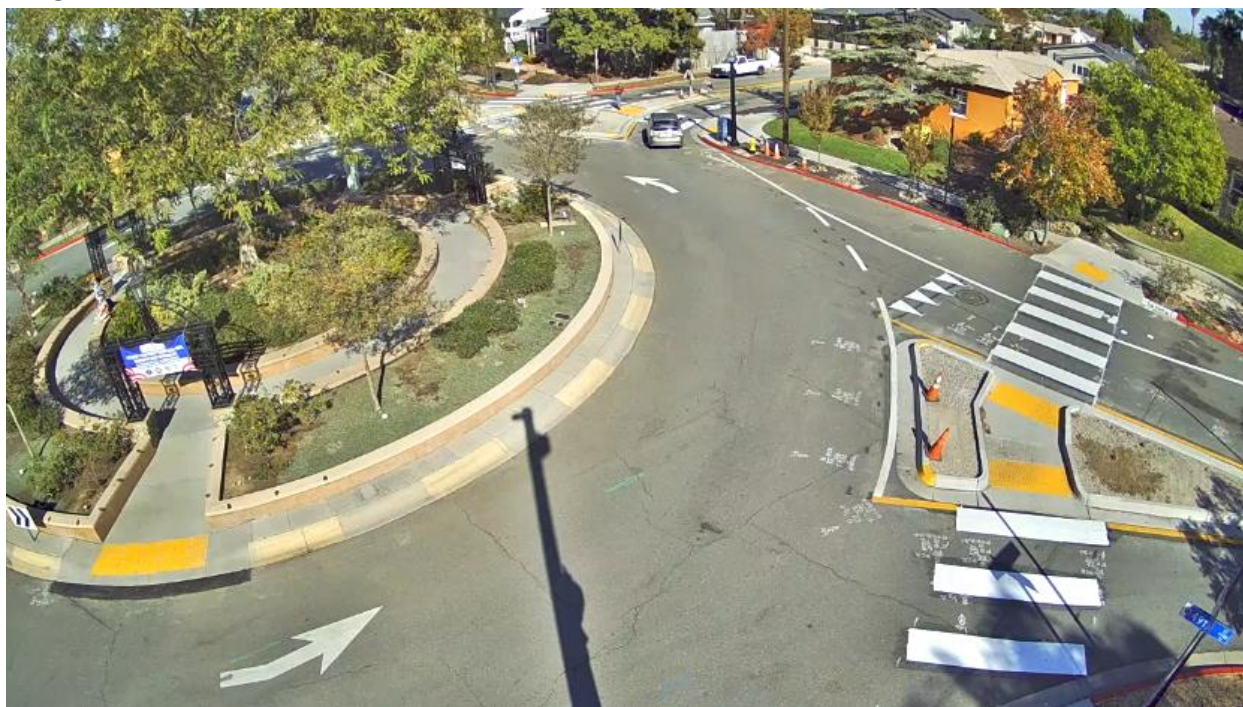
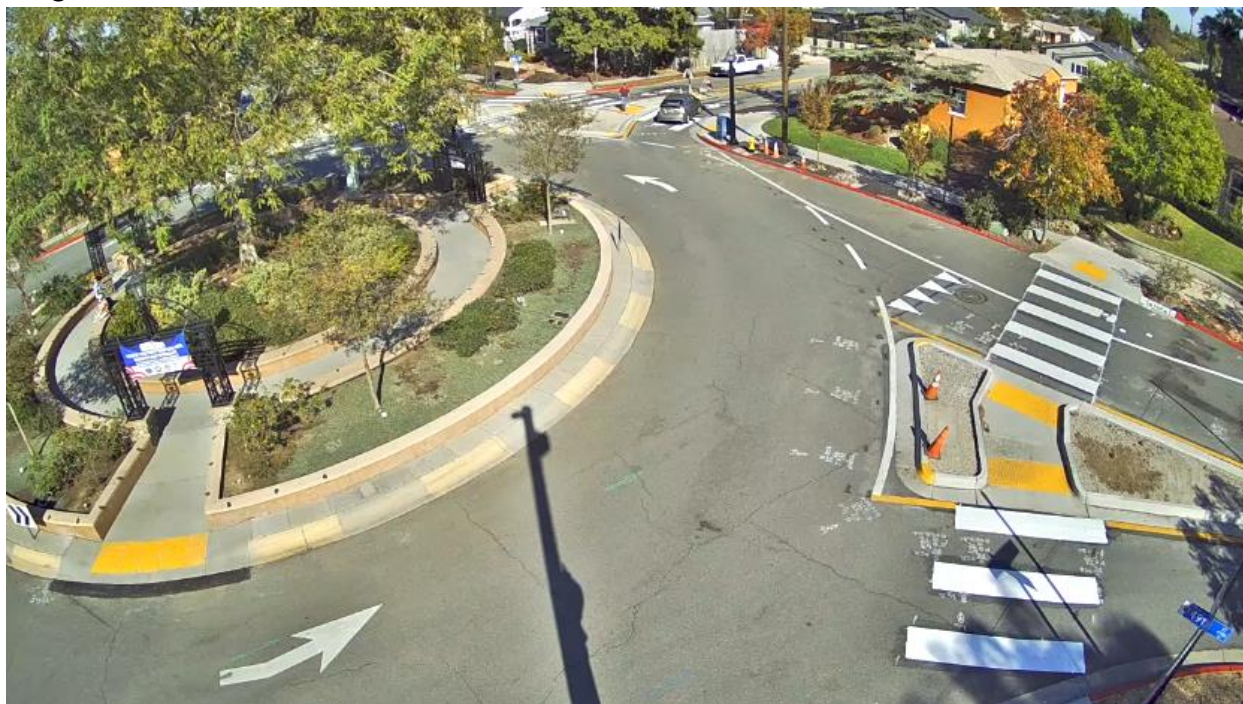
Interaction 5:

(Image 5-1) Pedestrian is crossing Adams East approaching island, and vehicle moves around roundabout. (Image 5-2) Pedestrian continues crossing and vehicle continues movement. (Image 5-3) Vehicle shows intent of exiting and pedestrian continues crossing. (Image 5-4) Pedestrian has reached Island and vehicle approaches crosswalk. (Image 5-5) Pedestrian waits on island after being ignored by driver.

Installation of the warning sign W11-2 and diagonal downward pointing arrow plaque W16-7P at the pedestrian crossings is recommended to encourage driver awareness and increase safety.

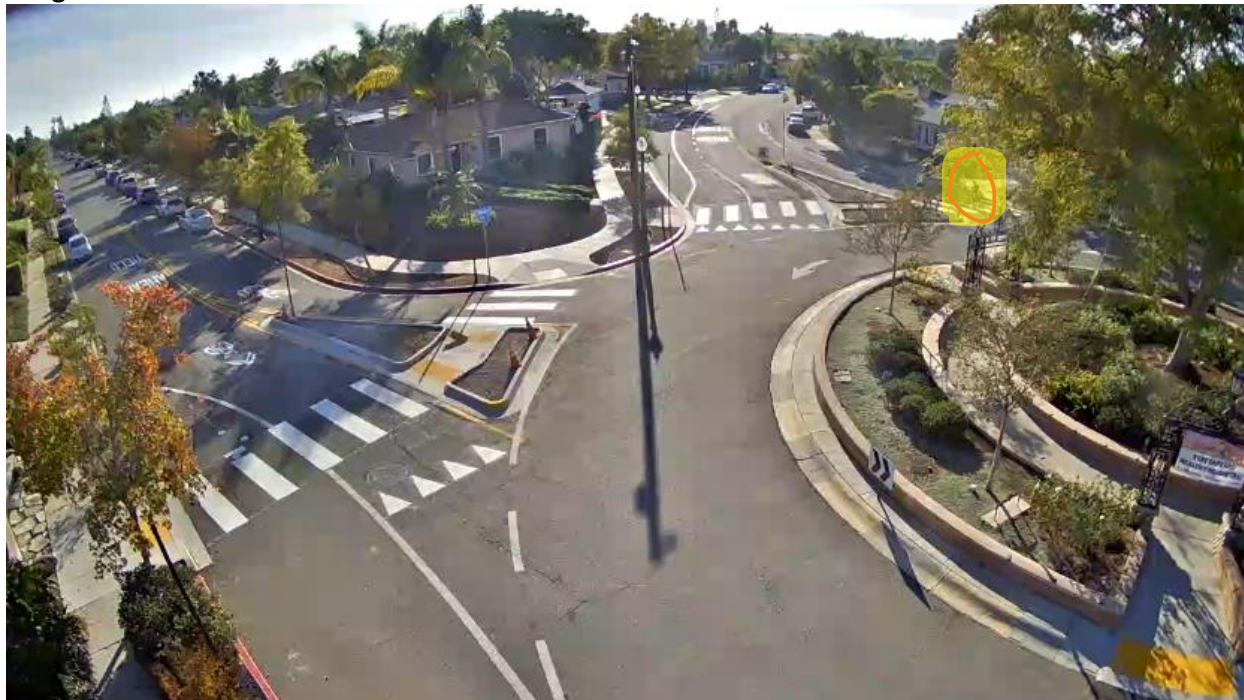
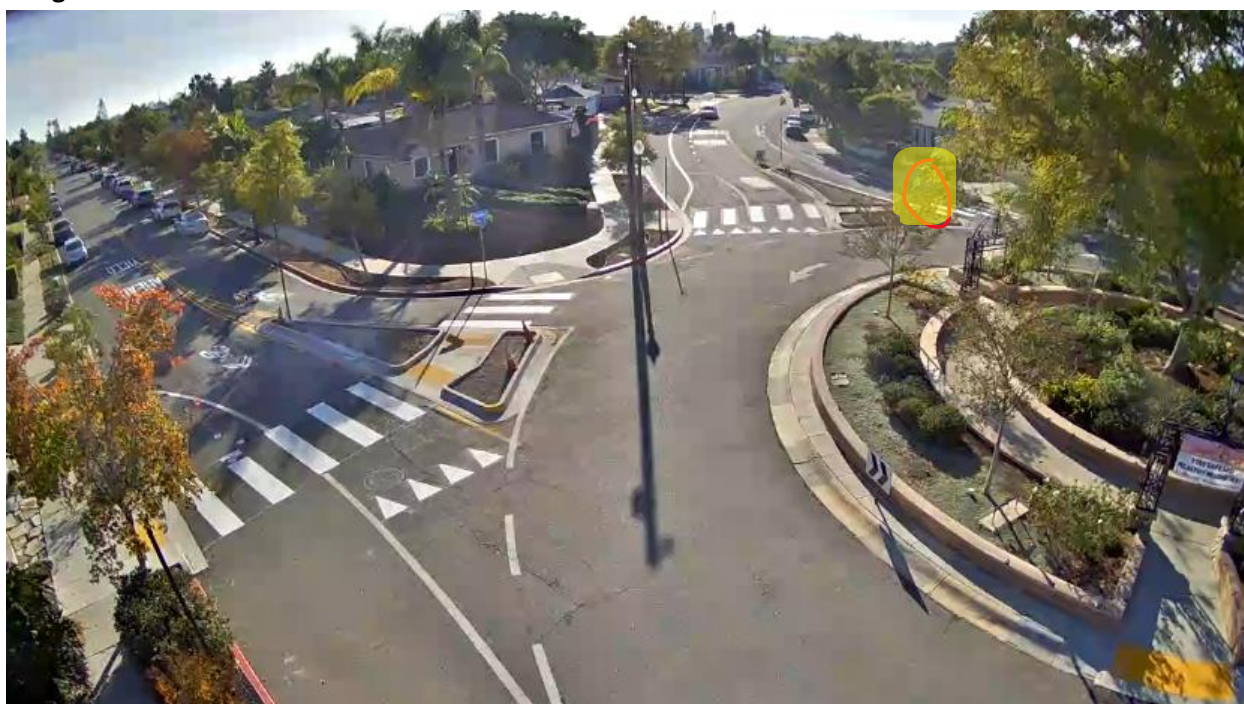
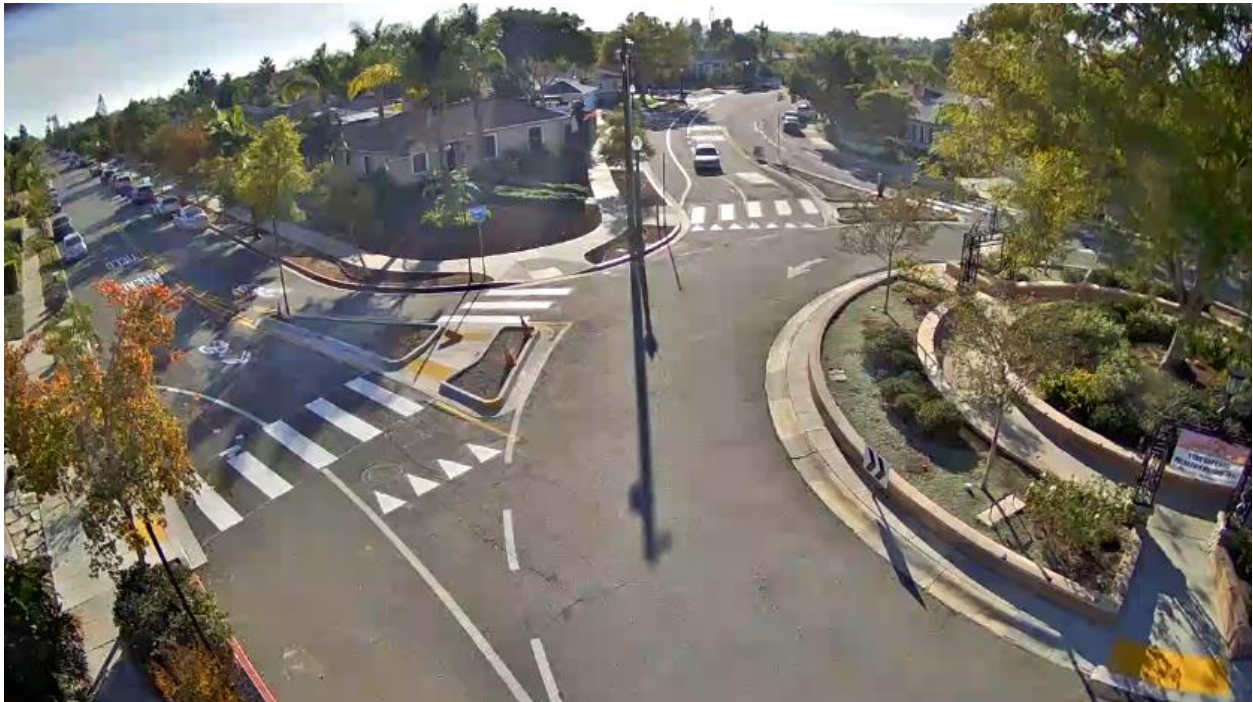
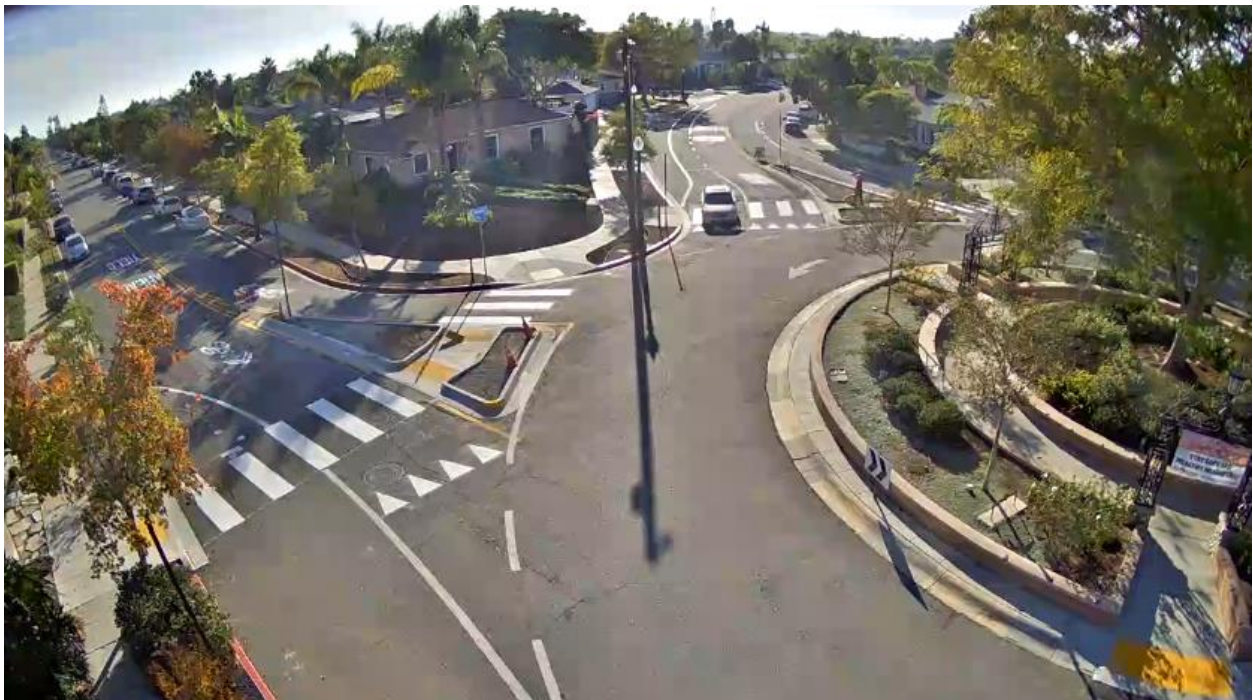
Interaction 6:

(Image 6-1) Pedestrian with dog crossing to island. (Image 6-2) Pedestrian stepping onto island and vehicle detected on approach. (Image 6-3) Pedestrian near island's ramp waits as driver does not seem to slow down. (Image 6-4) Driver ignores pedestrian and pedestrian crosses behind vehicle.

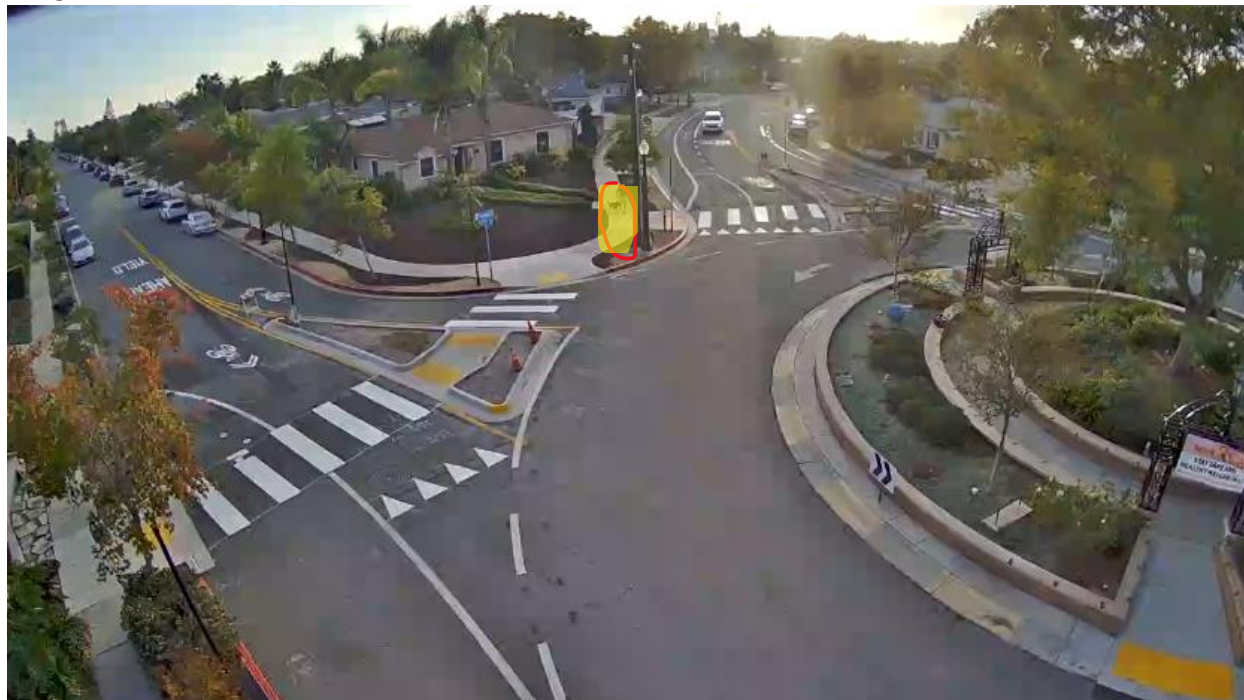
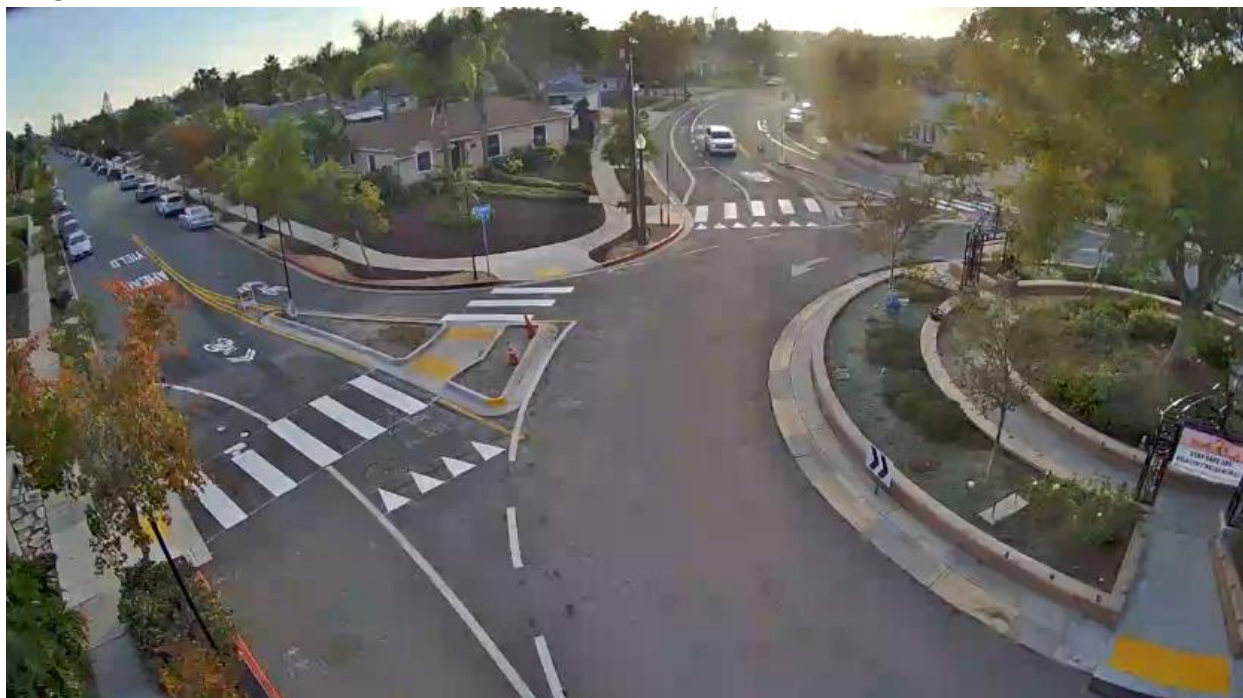
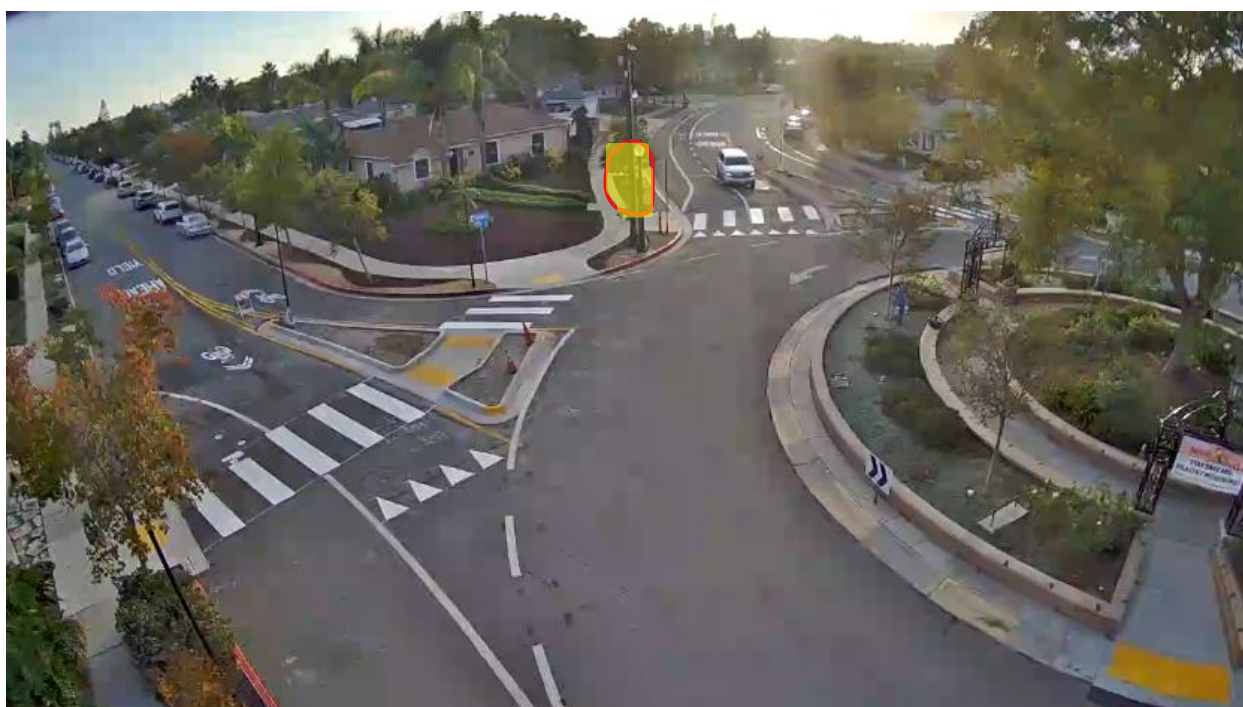
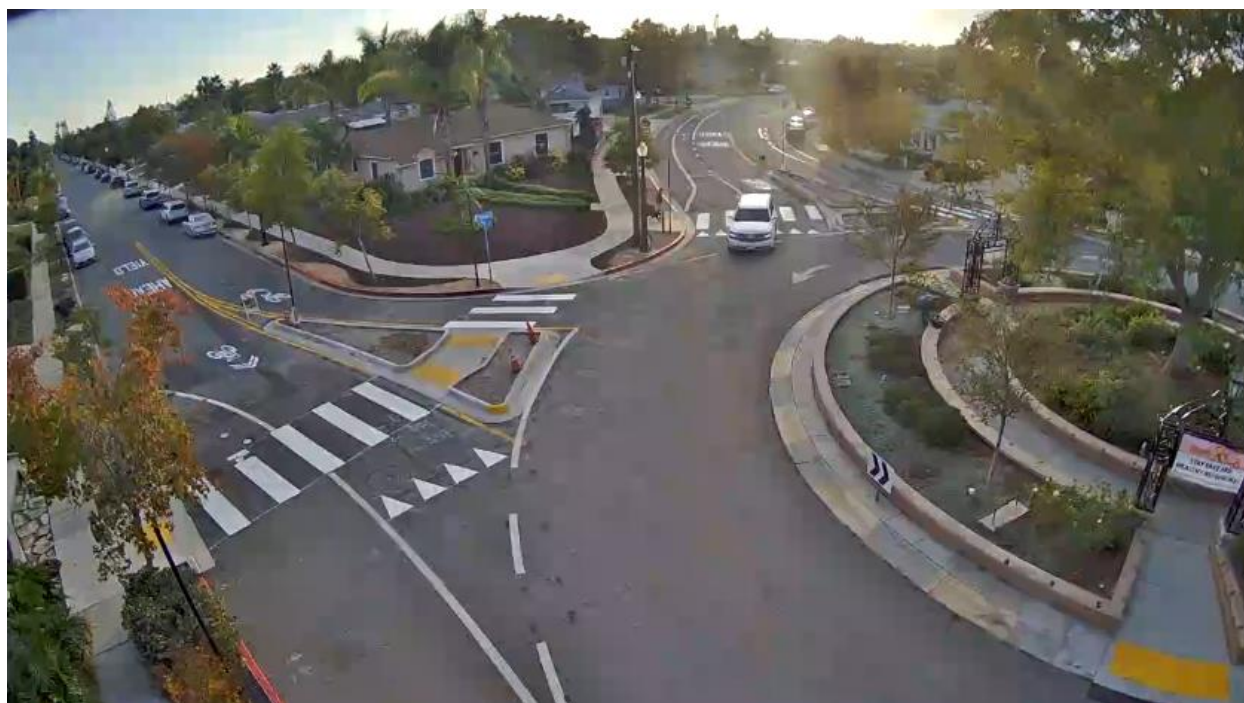
Interaction 7:

(Image 7-1) Pedestrian with dog approaches ramp and vehicle can be seen on approach. (Image 7-2) Pedestrian waiting behind ramp, and vehicle does not slow. (Image 7-3) Vehicle nearing crosswalk fails to yield to pedestrian. (Image 7-4) Ignored pedestrian crosses behind vehicle.

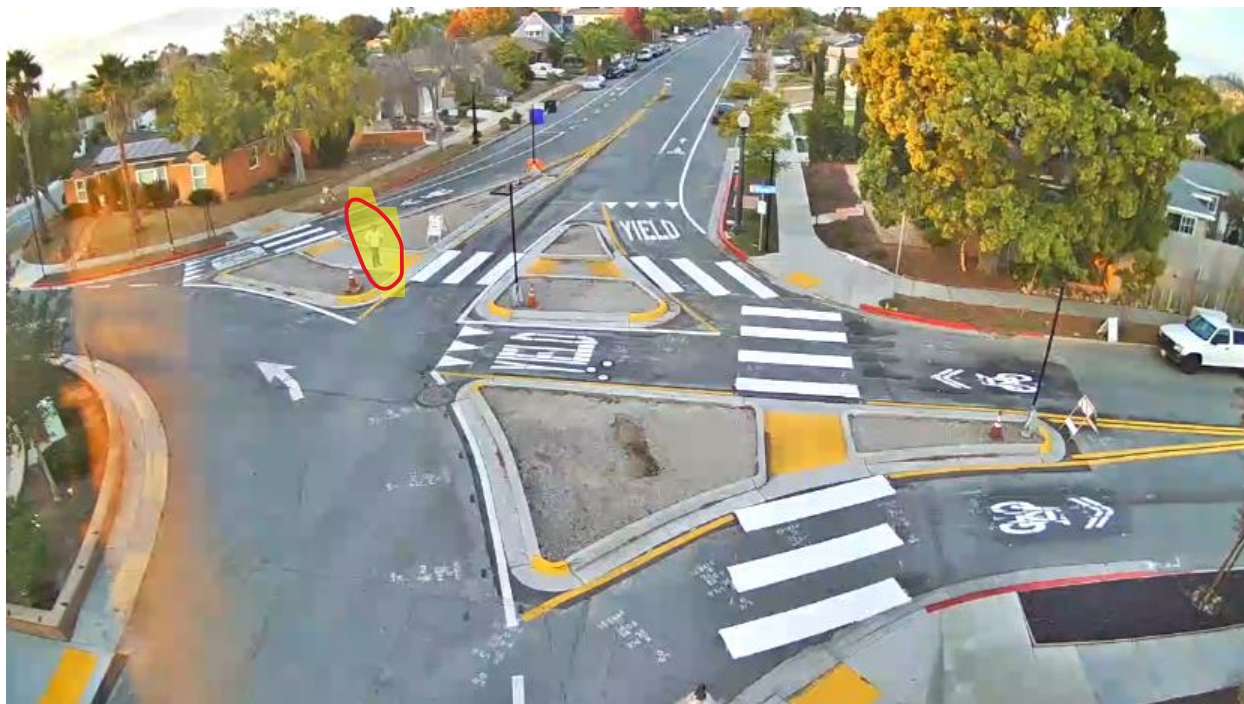
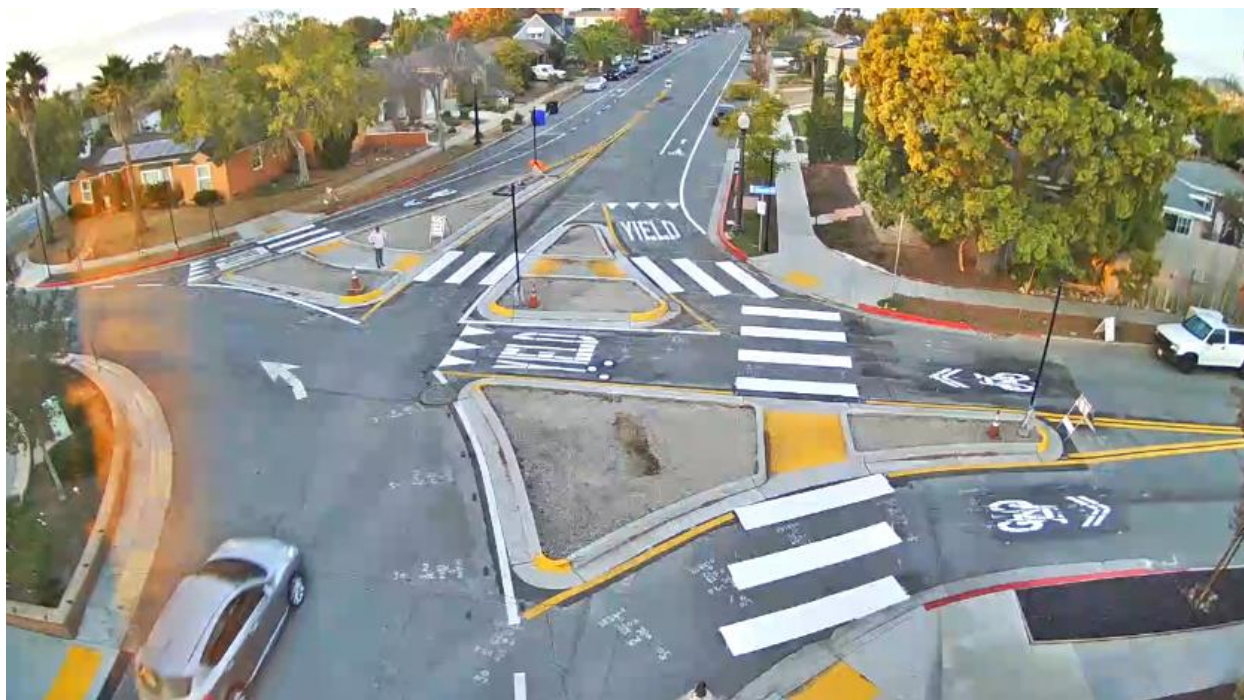
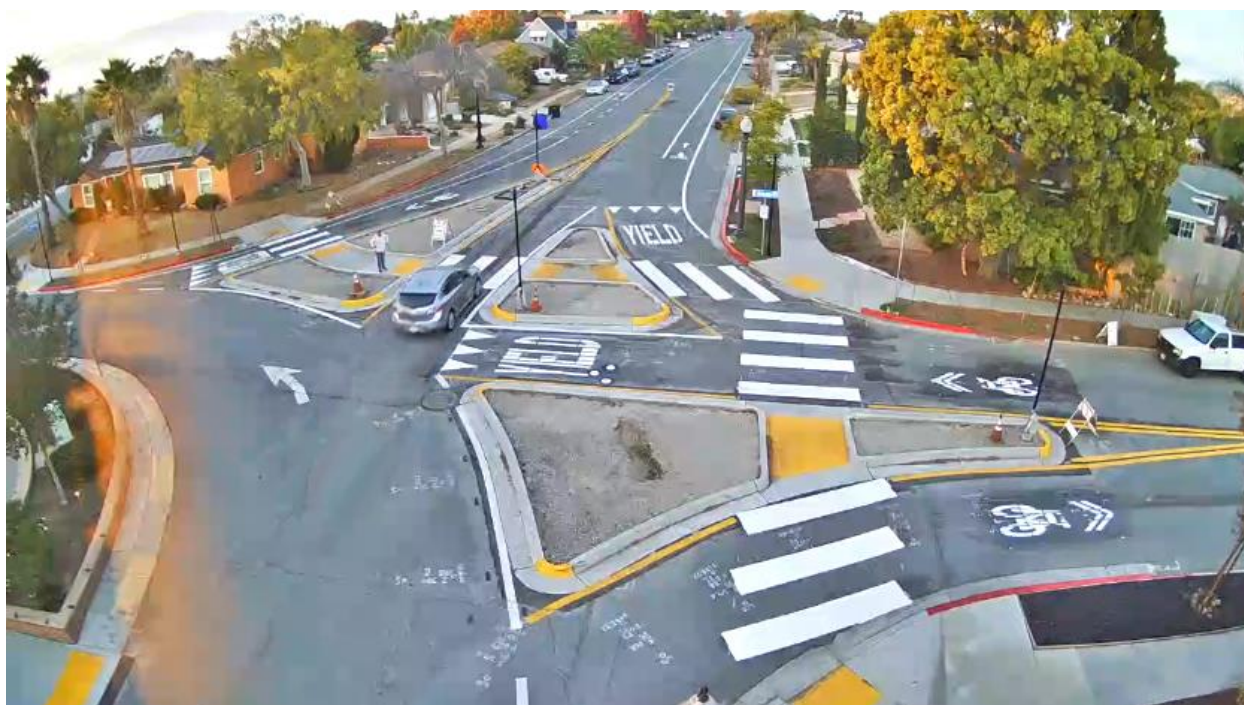
Interaction 8:

(Image 8-1) Pedestrian waiting at ramp looking down roundabout at approaching vehicle. (Image 8-2) Vehicle does not slow, and pedestrian remains on island's ramp. (Image 8-3) Driver passing through crosswalk fails to yield to pedestrian waiting on ramp.

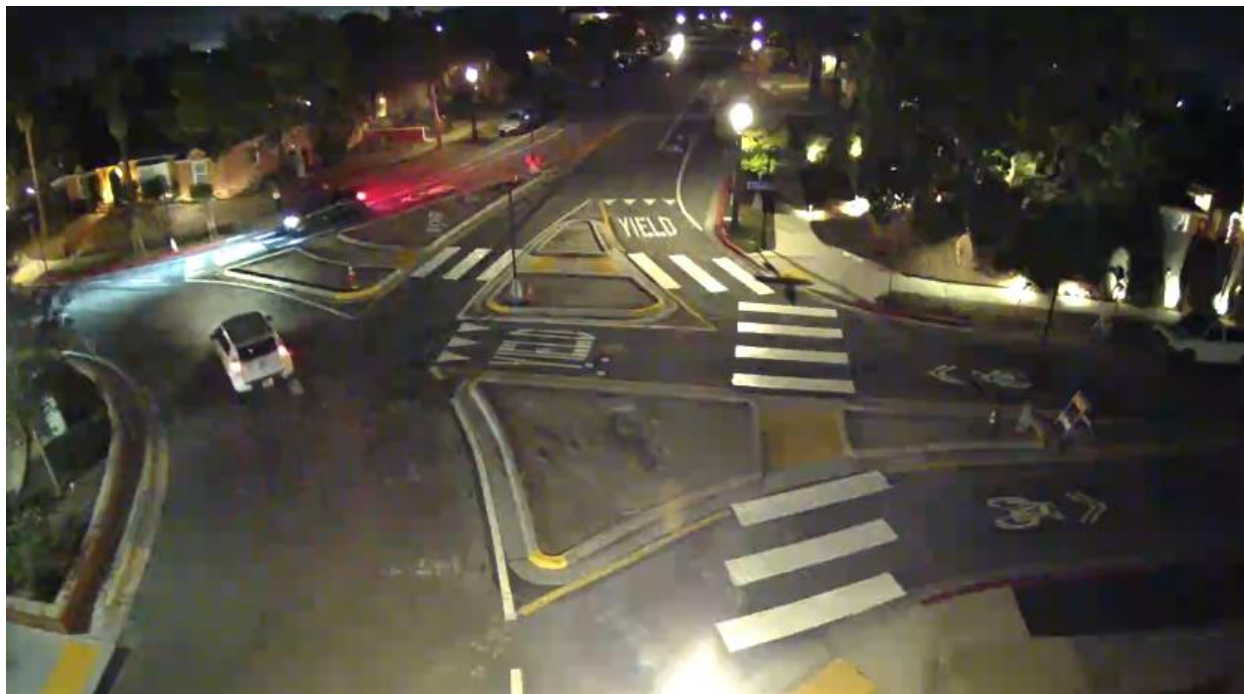
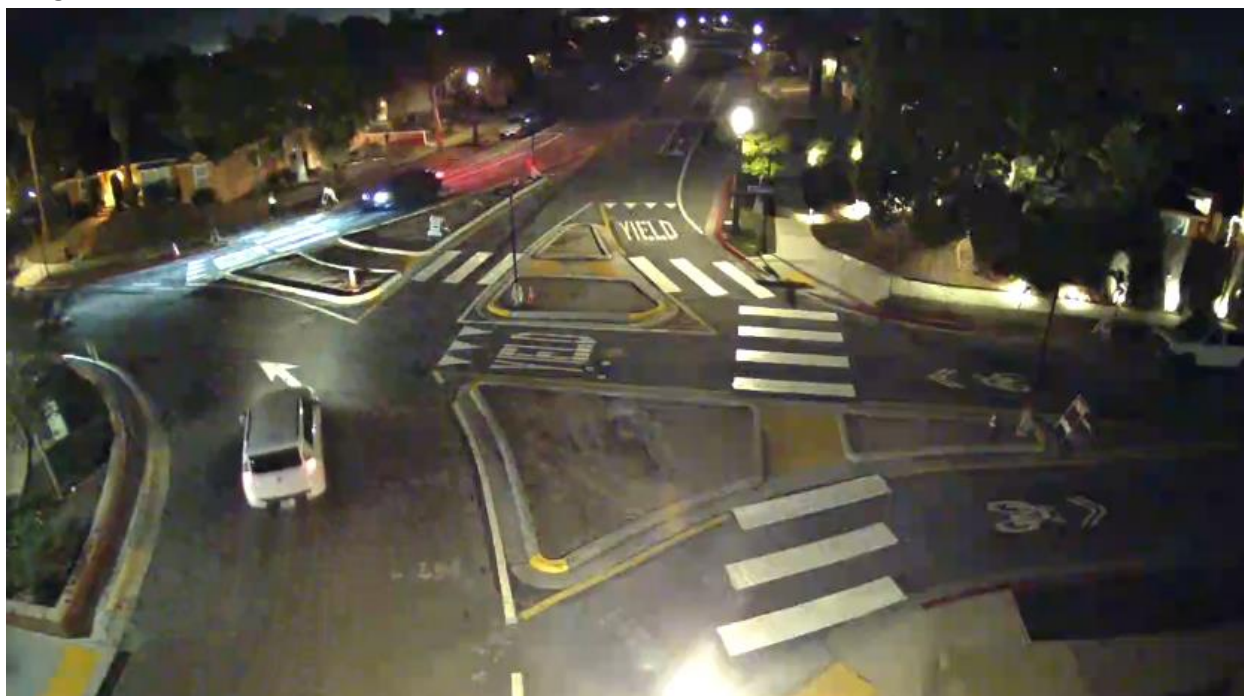
Interaction 9:

(Image 9-1) Vehicle on approach slows when approaching crosswalk as there is a vehicle going through the roundabout. (Image 9-2) Vehicle on approach proceeds to cover crosswalk and ignore pedestrian who waited at ramp during this interaction.
